Contingency Reserve Fund Study - Final

St. George the Martyr Church and Hall

Report No. 2302407.00
November 15, 2024

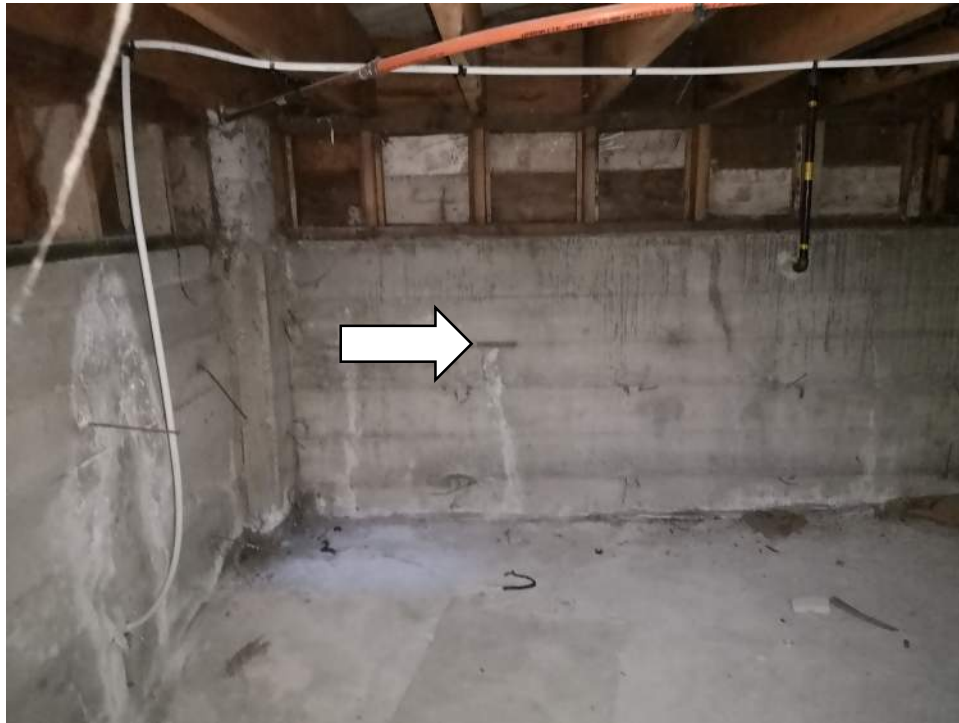
Photo - A10 00 00.01 - Foundations / Below-Grade

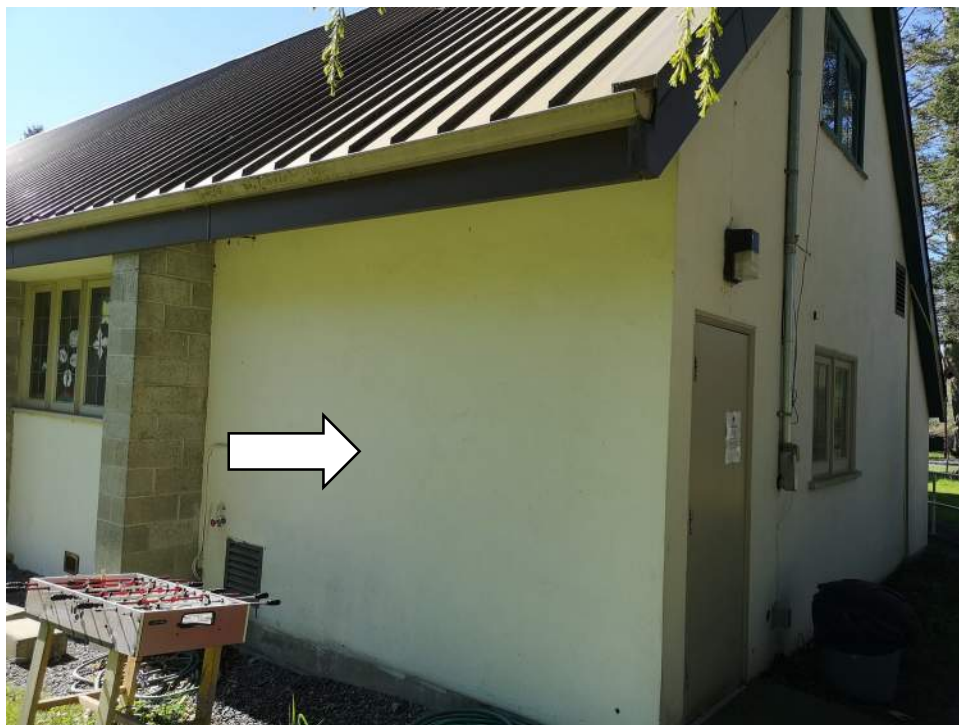
Photo - B20 10 01.01 - Stucco Cladding - Exterior Walls / Original Church

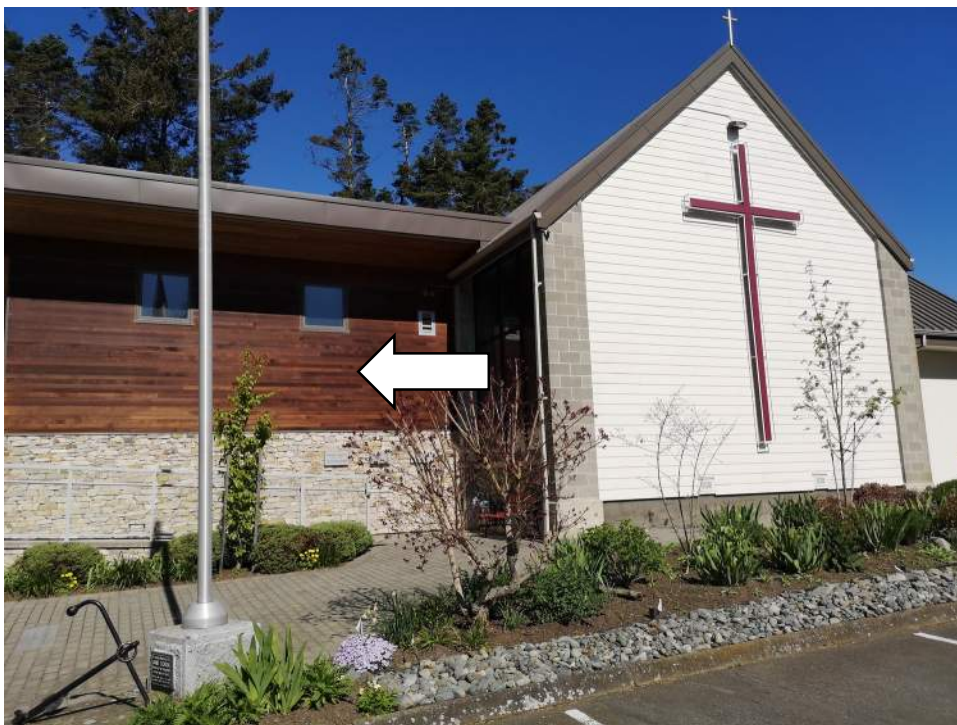
Photo - B20 10 01.05 - Cedar Cladding - Replacement / Narthex

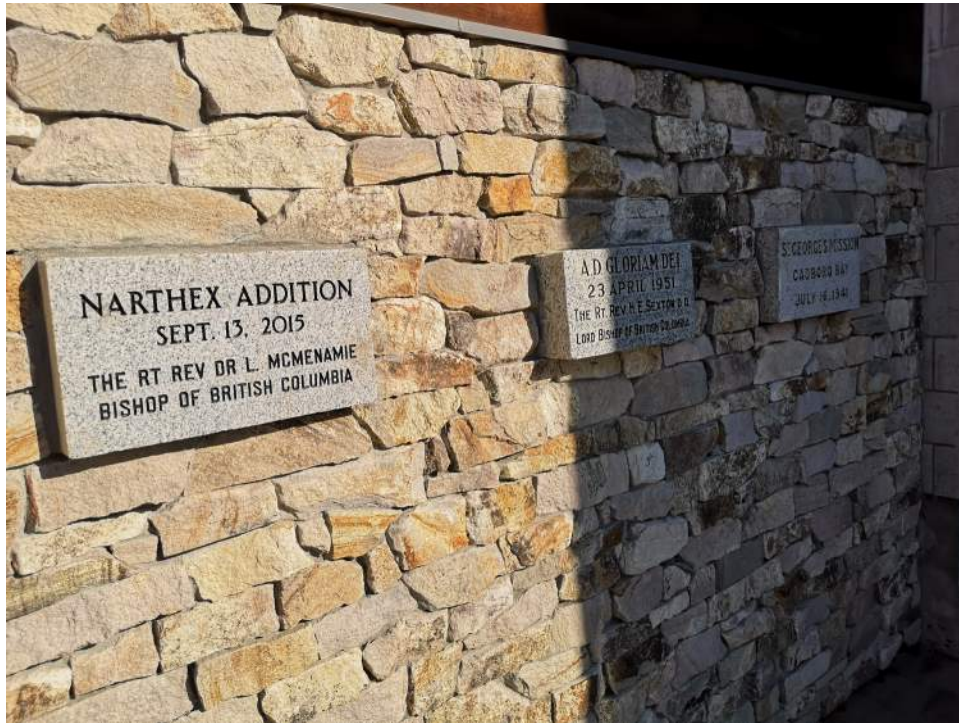
Photo - B20 10 01.07 - Stone Cladding - Replacement / Narthex

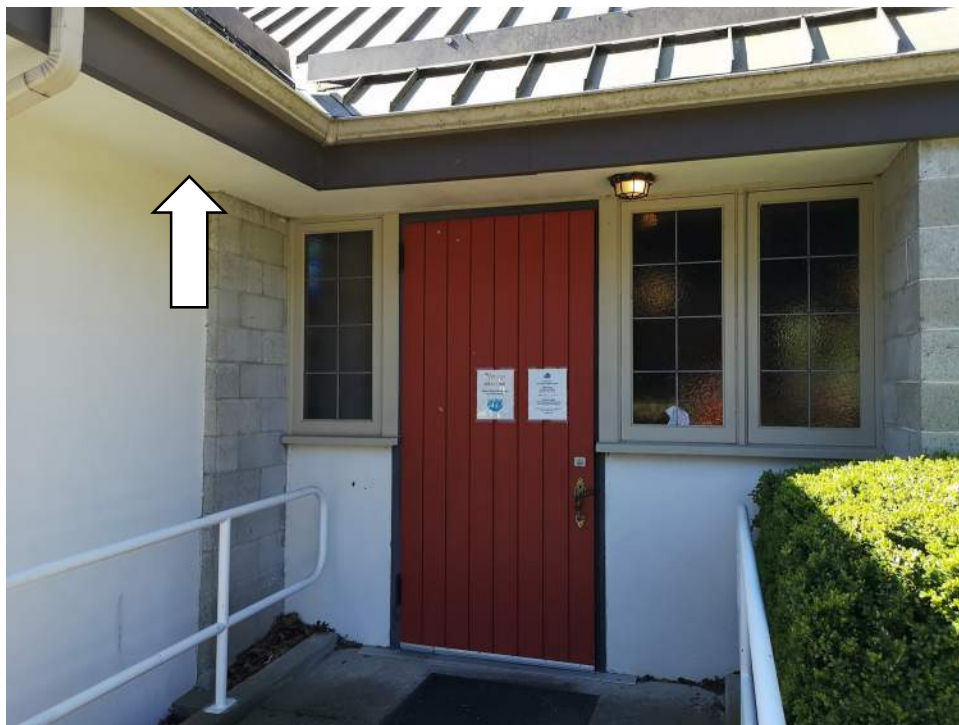
Photo - B20 10 08.01 - Soffits - Repaint and Repair / Roof Overhangs / Original Church

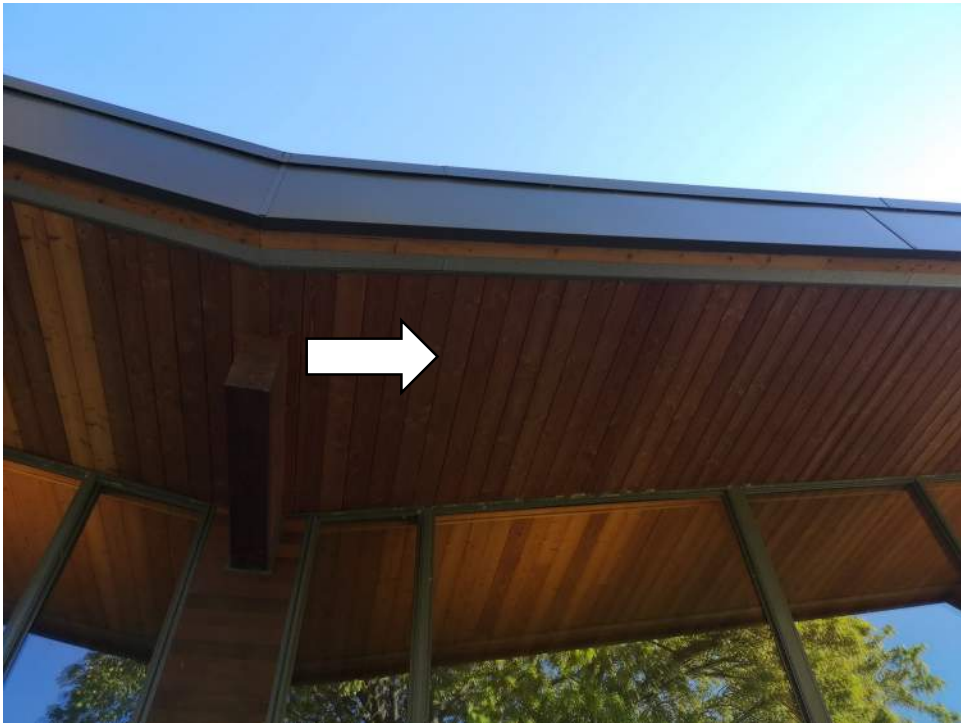
Photo - B20 10 08.02 - Soffits - Restain and Repair / Roof Overhangs / Narthex

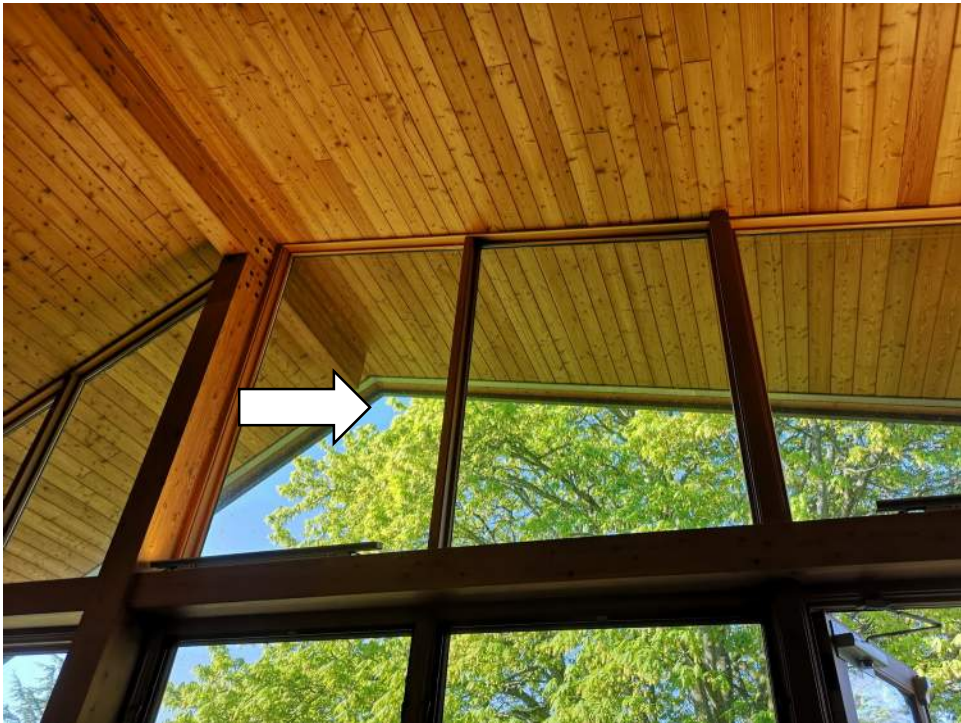
Photo - B20 20 01.01 - Exterior Windows, Wood-Framed - Replacement / Narthex

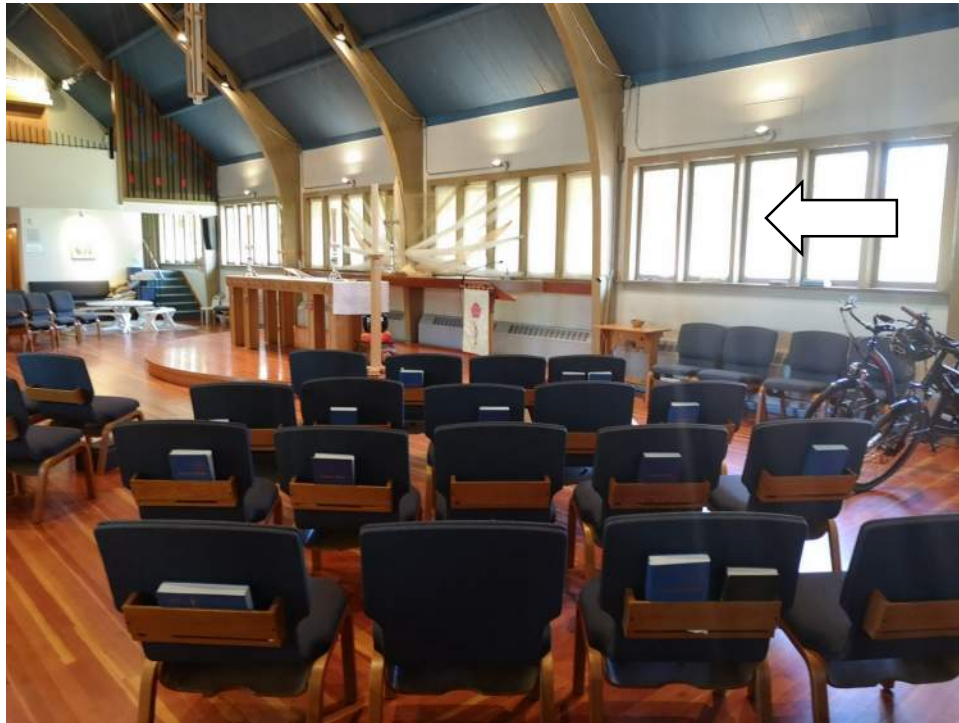
Photo - B20 20 01.03 - Exterior Windows, Wood-Framed - Replacement / Original Church

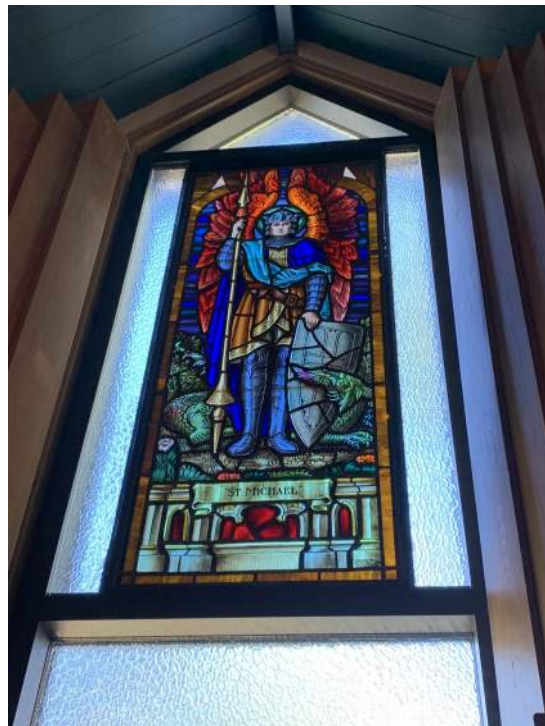
Photo - B20 20 01.04 - Exterior Stained Glass Windows, Aluminum-Framed - Replacement / Original Church

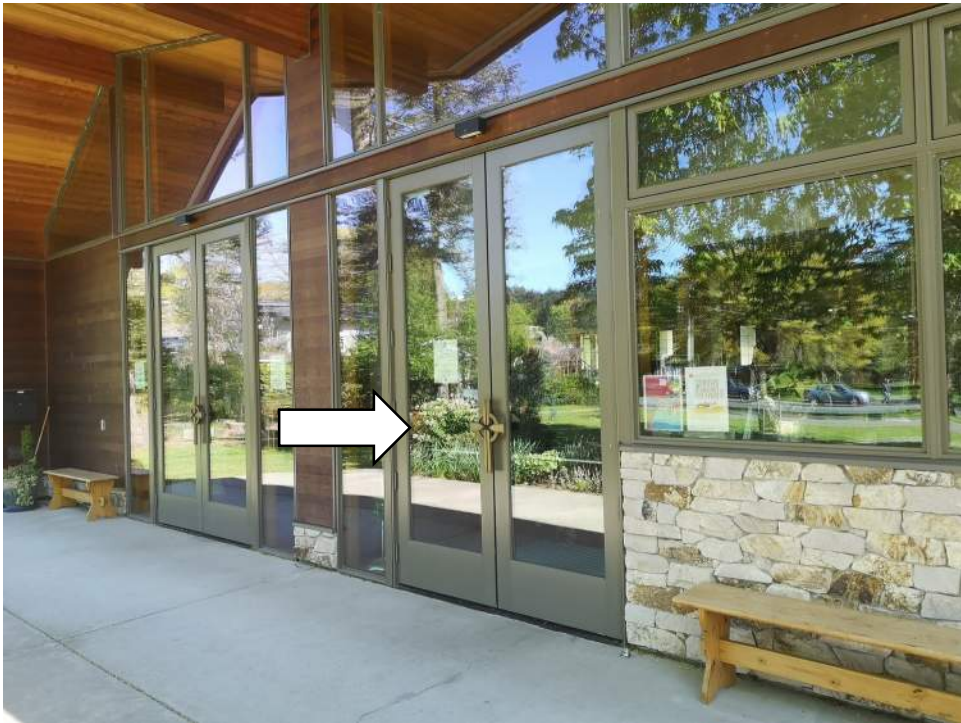
Photo - B20 30 02.00 - Glazed Swing Doors - Replacement / Narthex Entrance

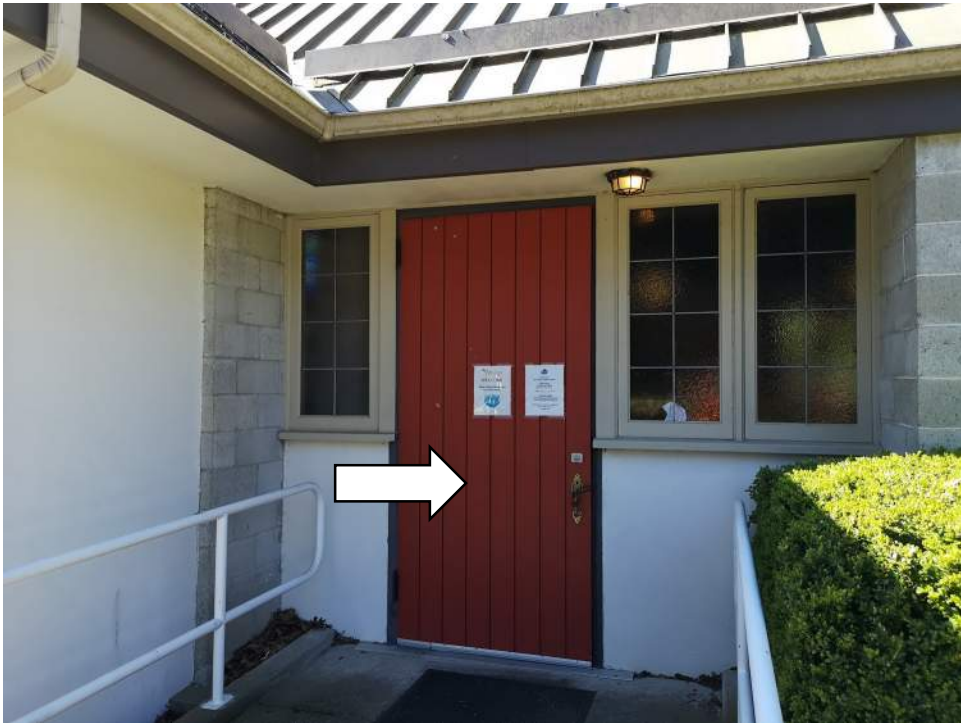
Photo - B20 30 99.00 - Swing Doors - Replacement / Building Entrances

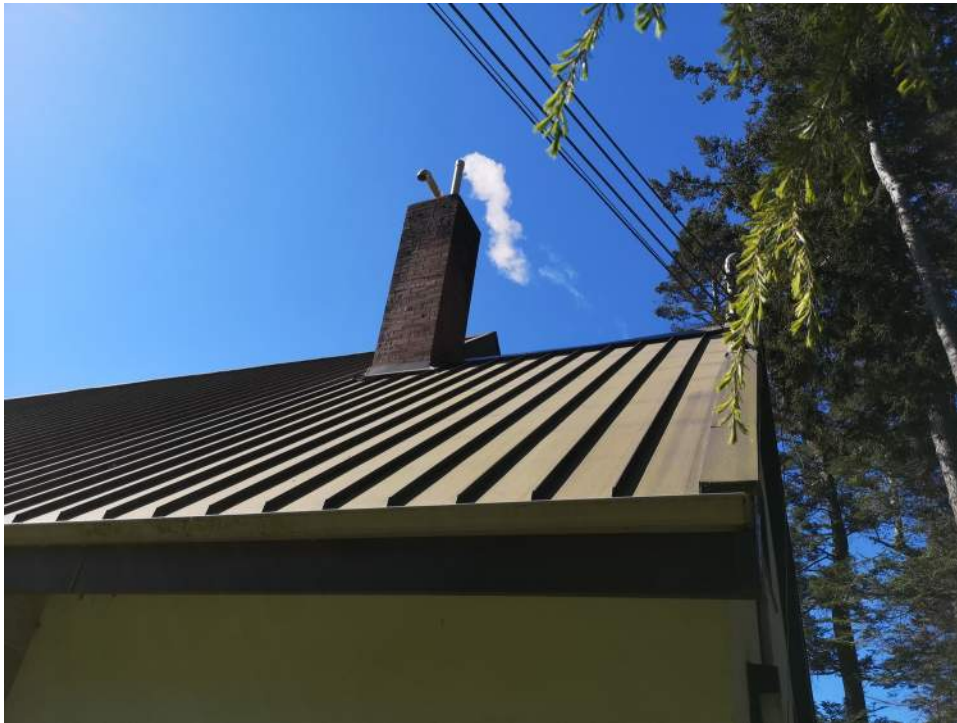
Photo - B30 10 01.01 - Standing Seam Metal Roof - Replacement / High Slope Roof Coverings

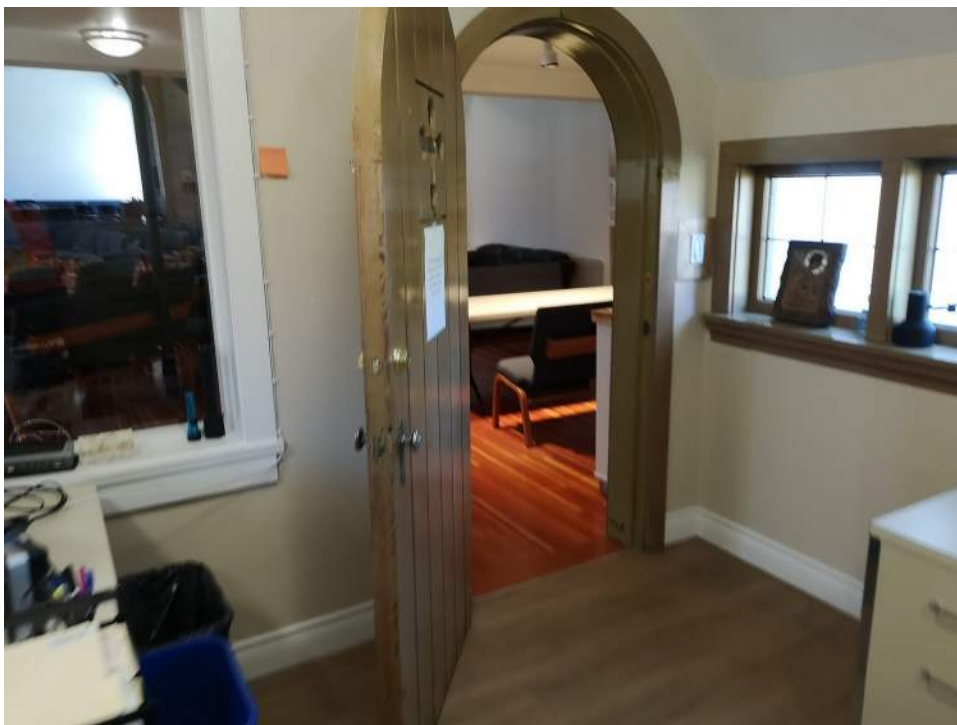
Photo - C10 20 03.01 - Interior Doors - Repairs / Original Church

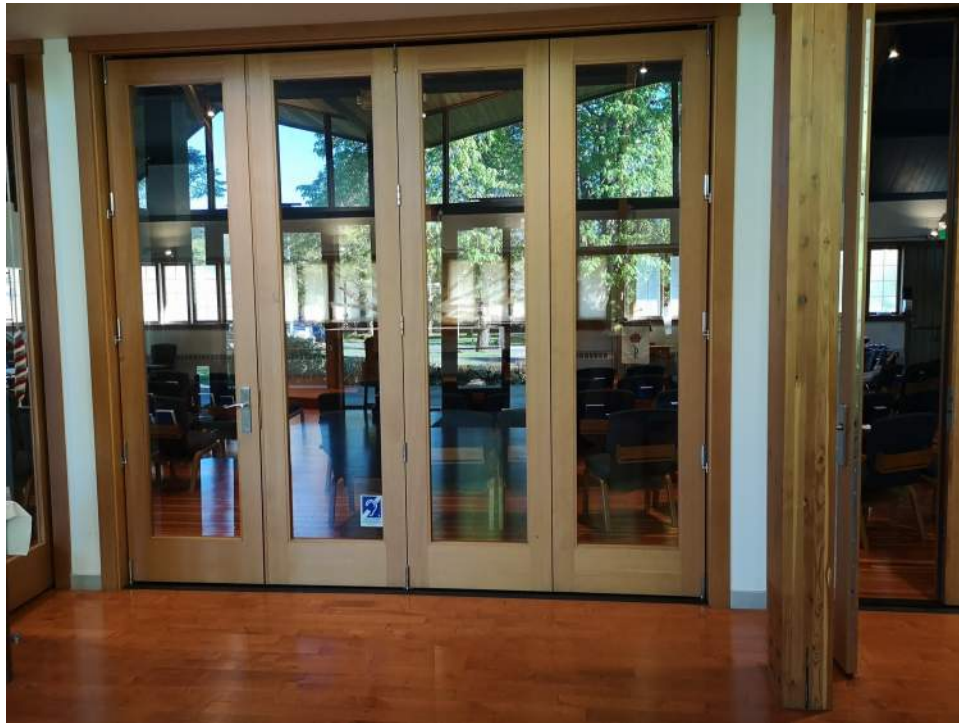
Photo - C10 20 03.02 - Interior Doors - Repairs / Narthex

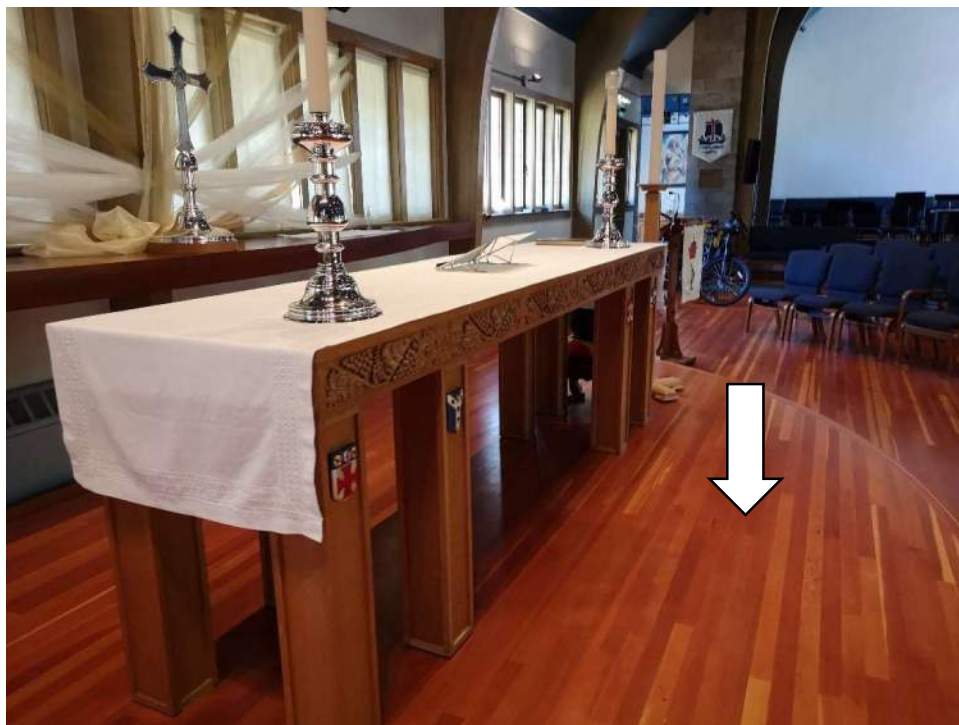
Photo - C30 00 00.01 - Interior Finishes and Furnishings - Hardwood Floor / Original Church

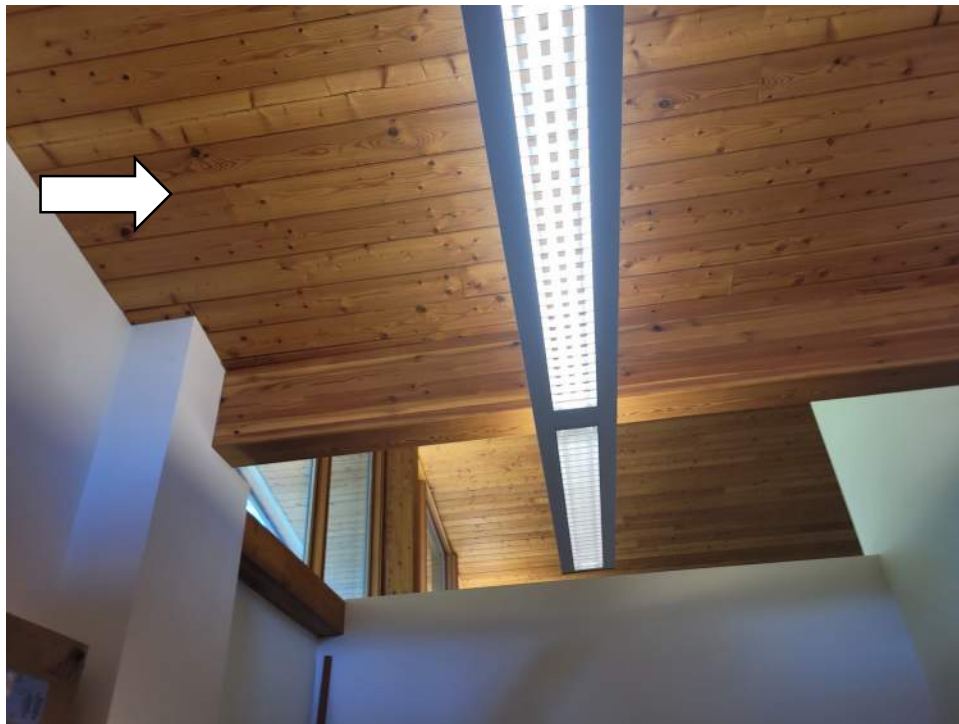
Photo - C30 00 00.08 - Interior Finishes and Furnishings - Stained Shiplap Board Ceiling / Narthex

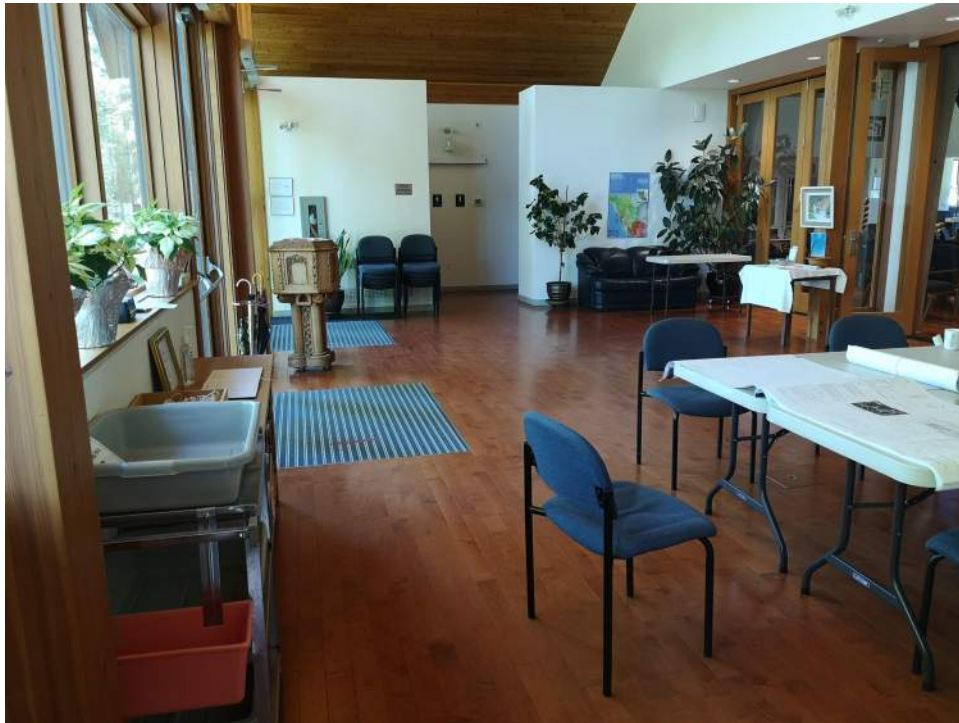
Photo - C30 00 00.09 - Interior Finishes and Furnishings - Furniture and Equipment / Narthex

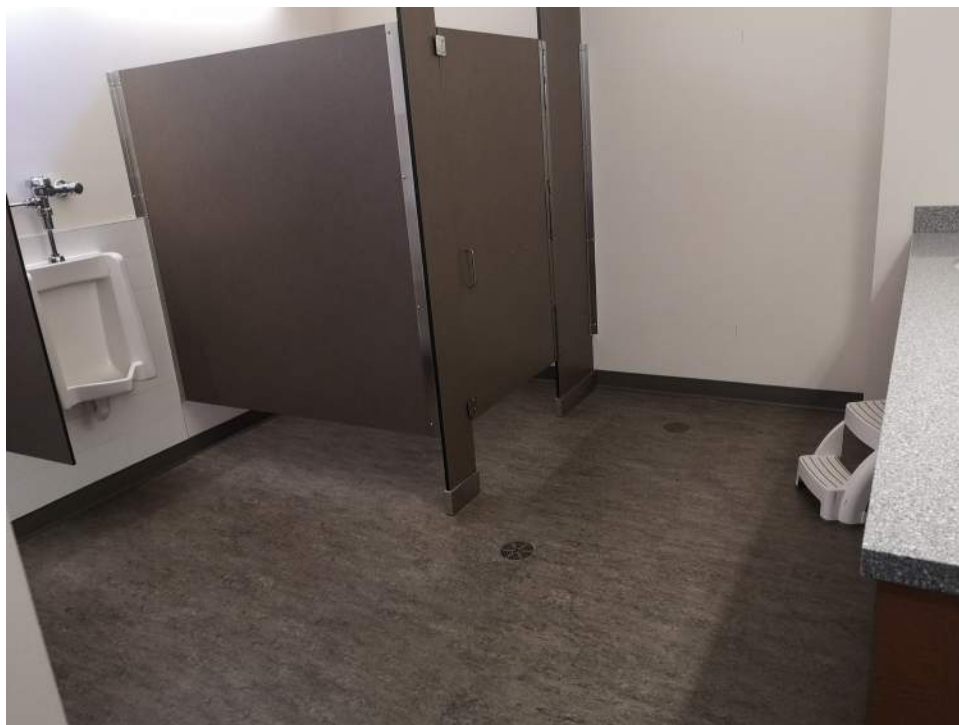
Photo - D20 10 00.00 - Plumbing Fixtures - Replacement / Common Area Washrooms

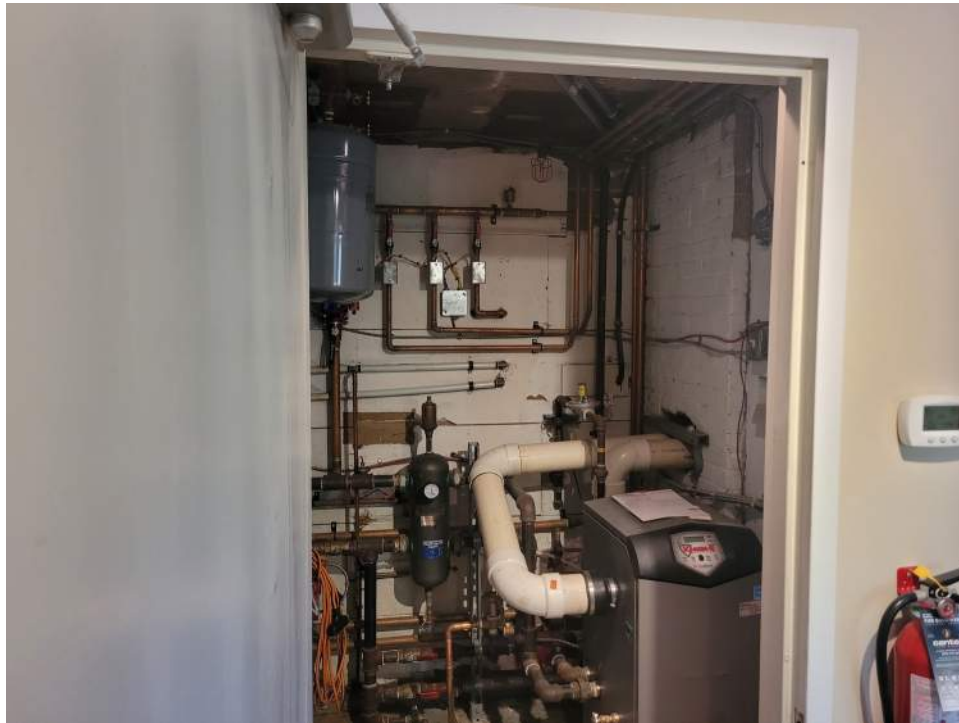
Photo - D20 20 30.00 - Boiler - Replacement / Church Boiler Room

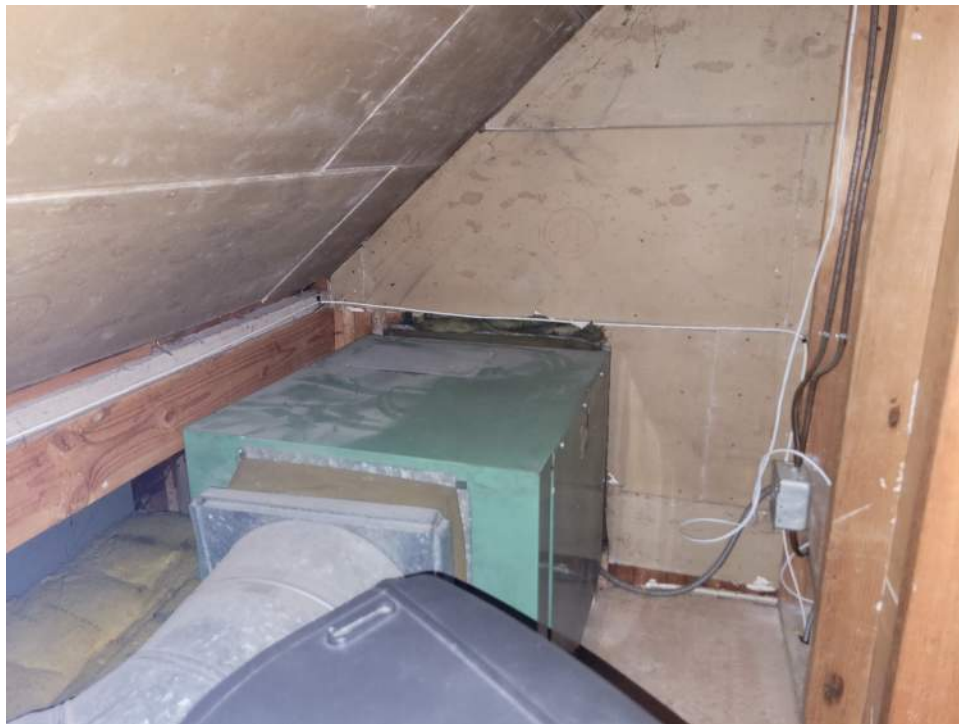
Photo - D30 40 08.00 - Air Handling Unit - Replacement / Upper Floor Office, Storage Space - Under Sloped Roof

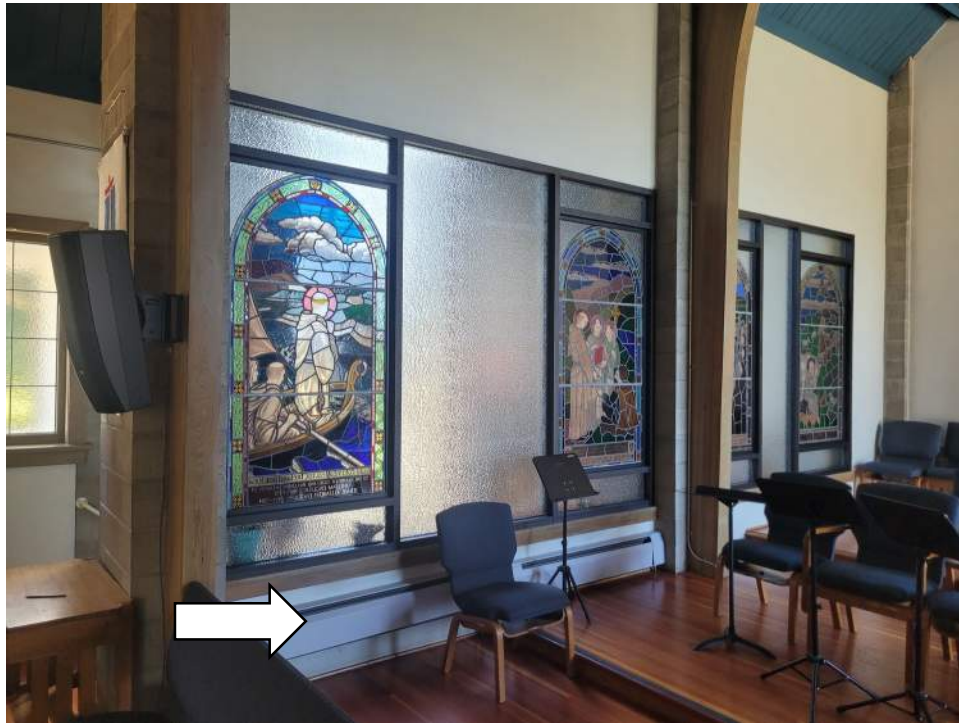
Photo - D30 50 06.02 - Hydronic Baseboard Heaters - Replacement / Original Church

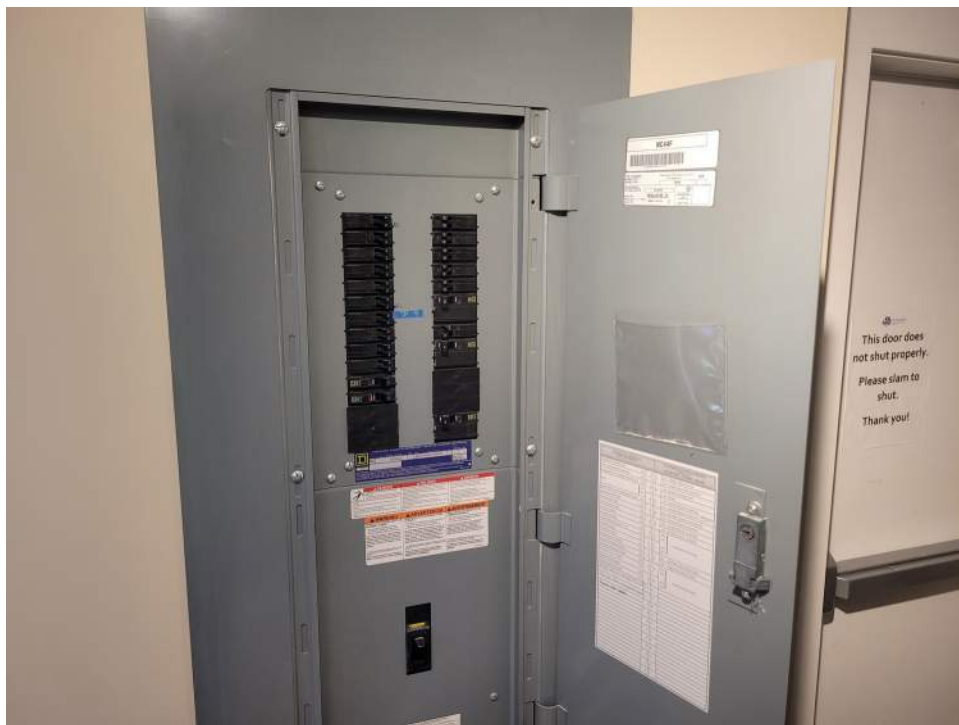
Photo - D50 10 05.00 - Branch Circuit Panels - Replacement / Office Area and Men's Washroom

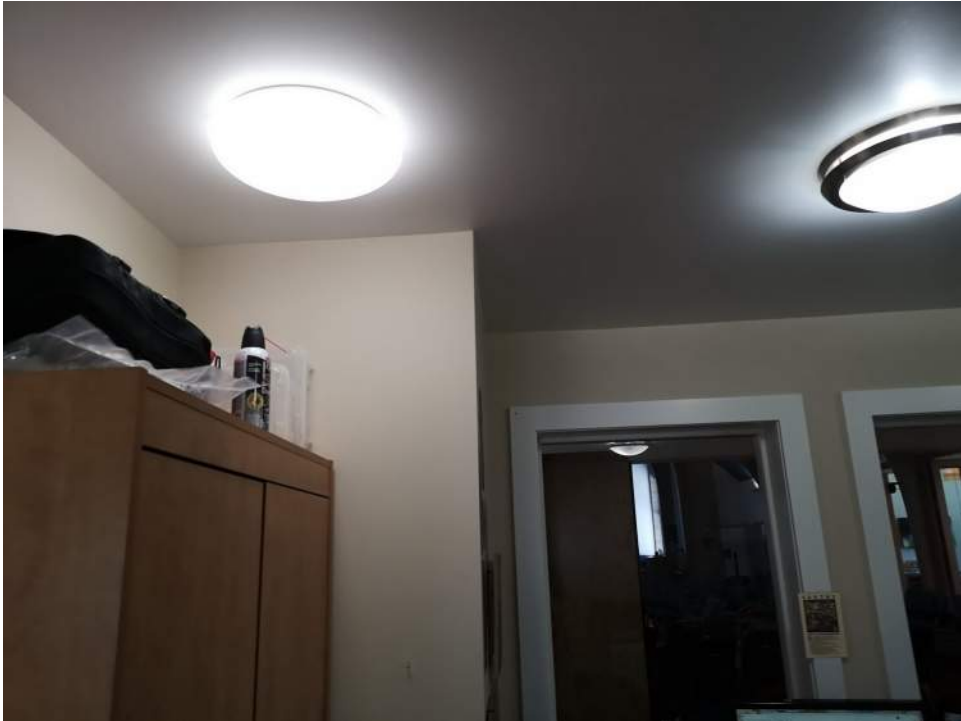
Photo - D40 20 02.01 - Interior Lighting - Replacement / Original Church

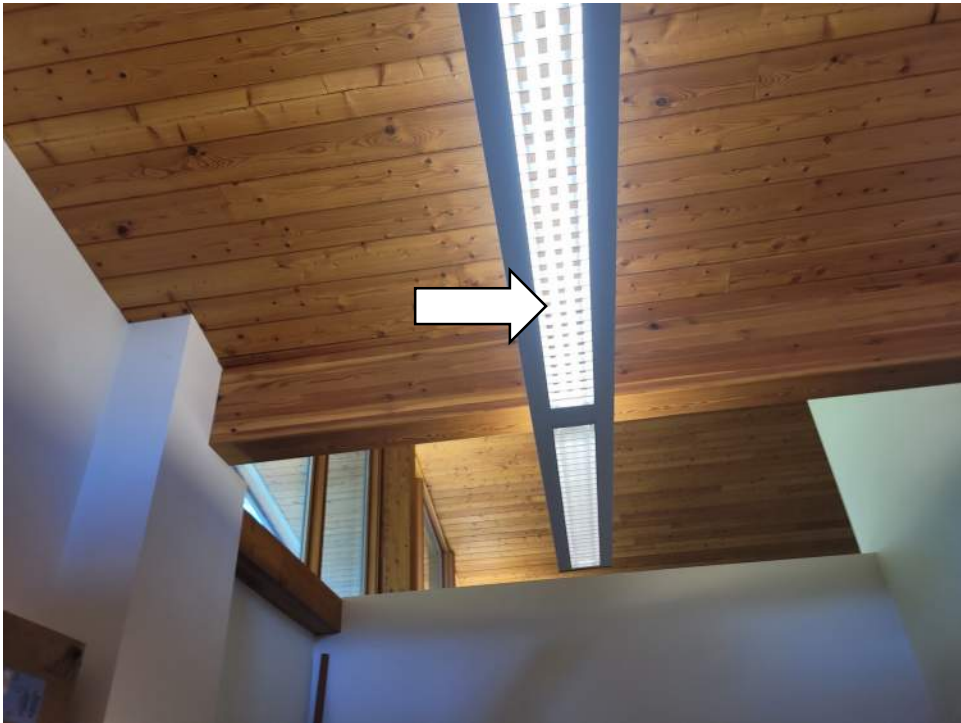
Photo - D40 20 02.02 - Interior Lighting - Replacement / Narthex

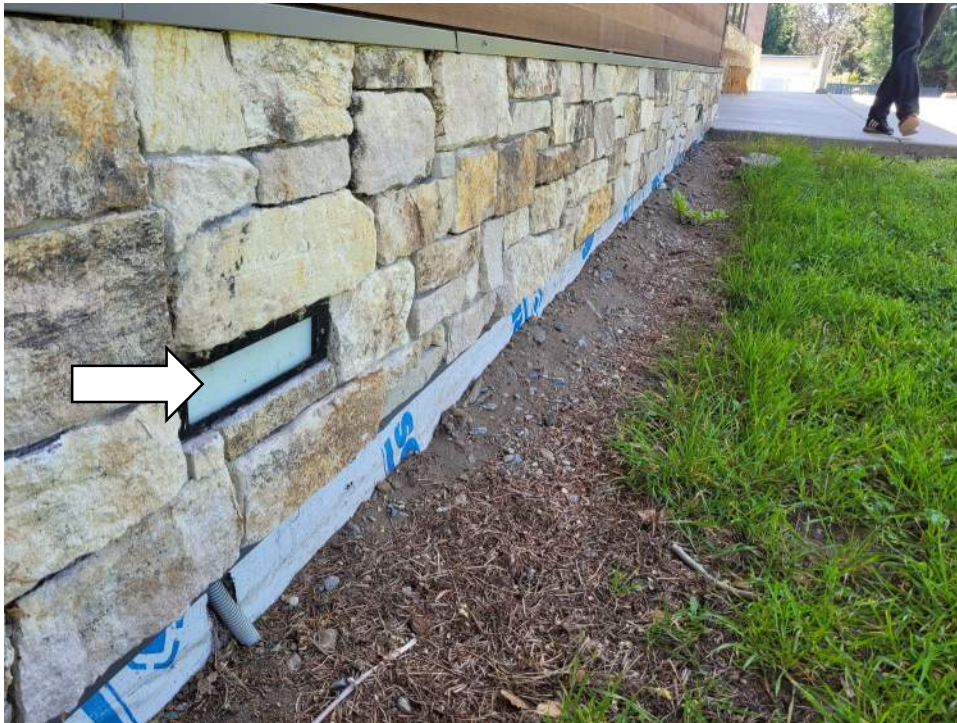
Photo - D40 20 06.01 - Exterior Lighting - Replacement / Rockwall-Mounted at Narthex

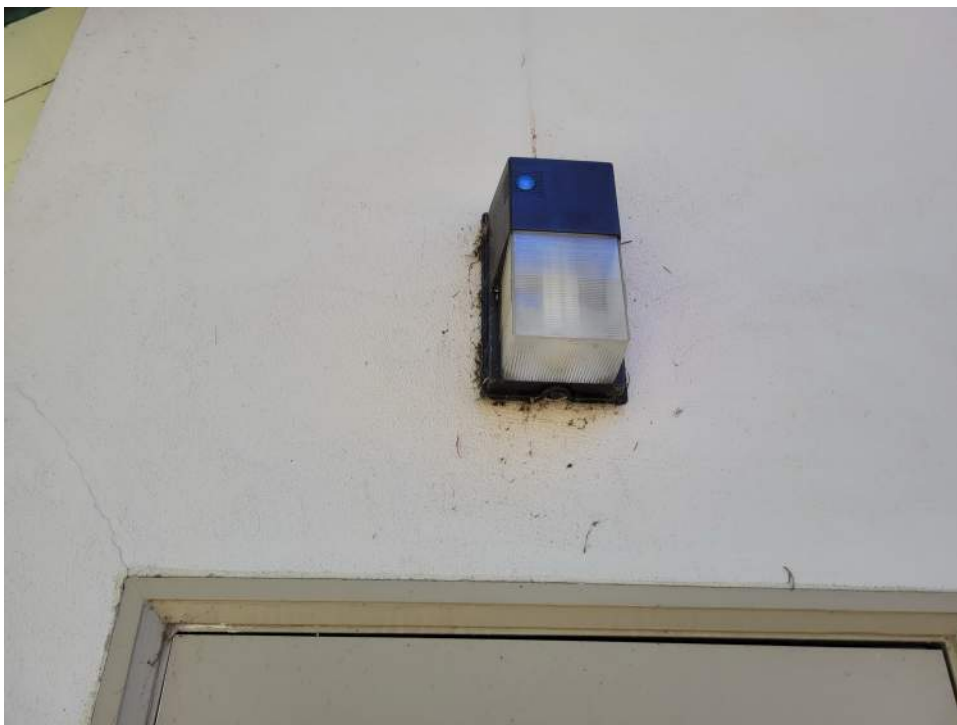
Photo - D40 20 06.02 - Exterior Lighting - Replacement / Wall-Mounted at Church

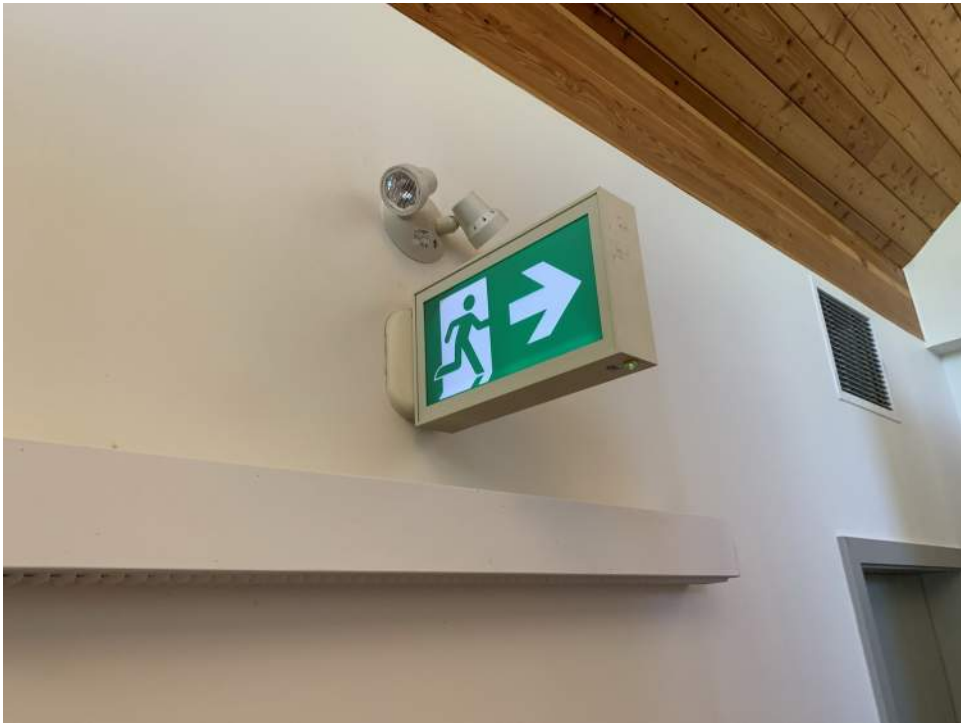
Photo - D40 20 08.00 - Emergency and Exit Lighting - Replacement / Paths of Egress

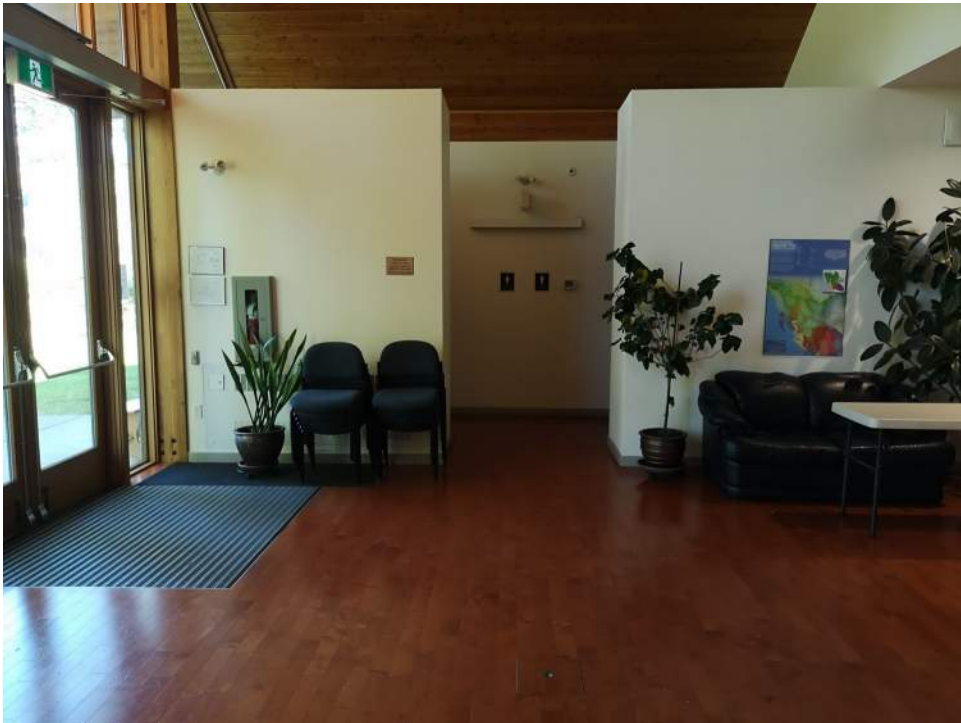
Photo - D40 30 03.00 - Fire Alarm System - Replacement / Throughout

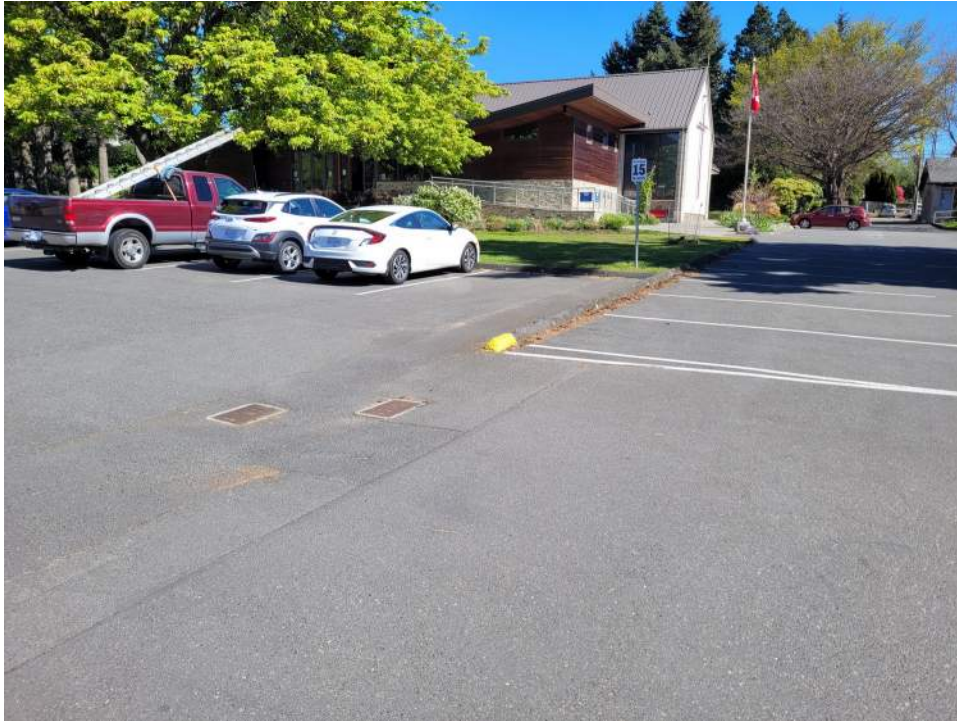
Photo - G20 20 03.01 - Asphalt Pavement - Resurfacing / Parking Areas

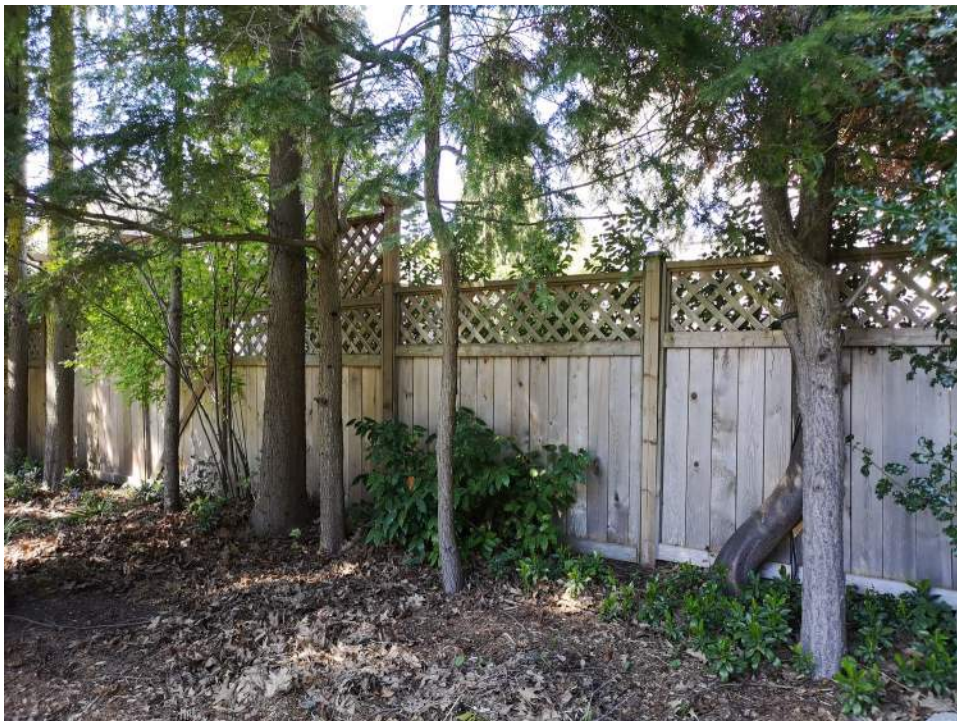
Photo - G20 40 01.01 - Fences - Replacement / Site Perimeter

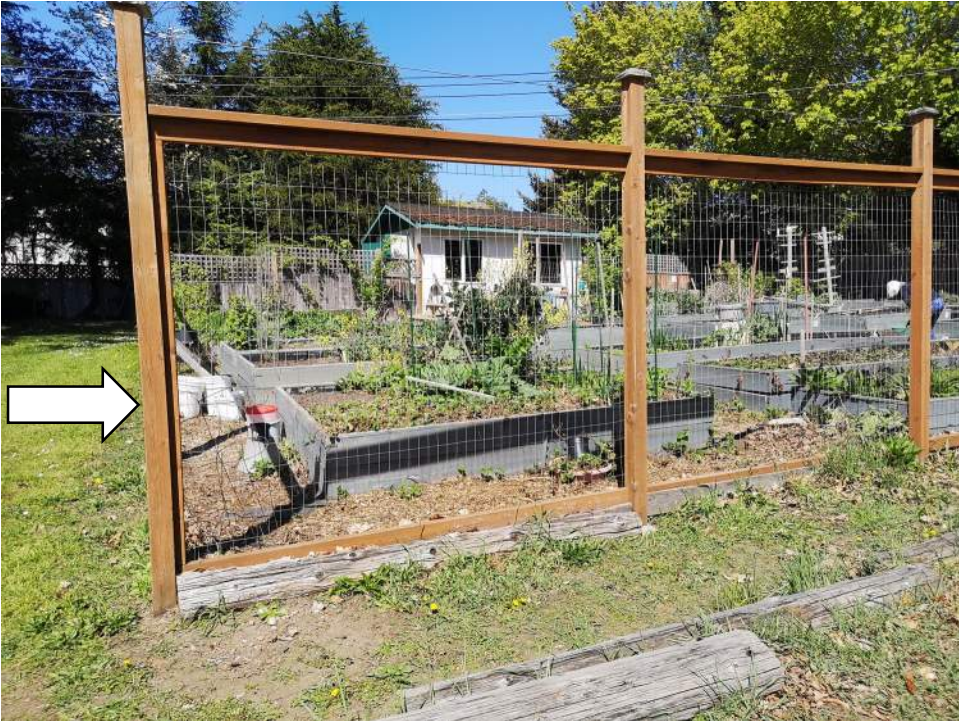
Photo - G20 40 01.02 - Fences - Replacement / Around Garden Beds

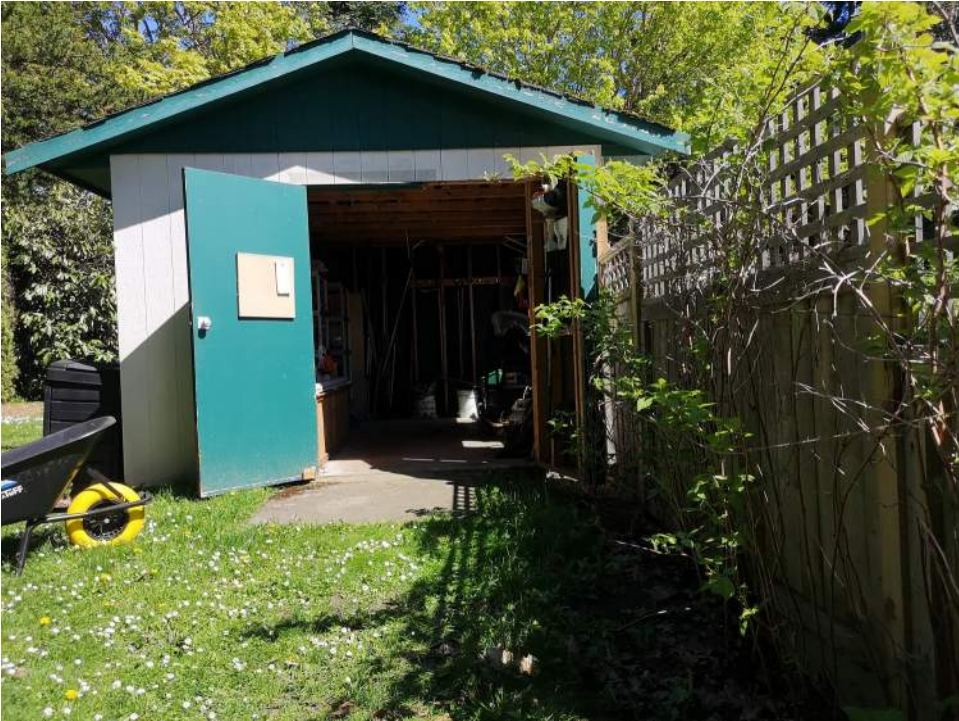
Photo - G20 40 99.01 - Garden Shed / Repair

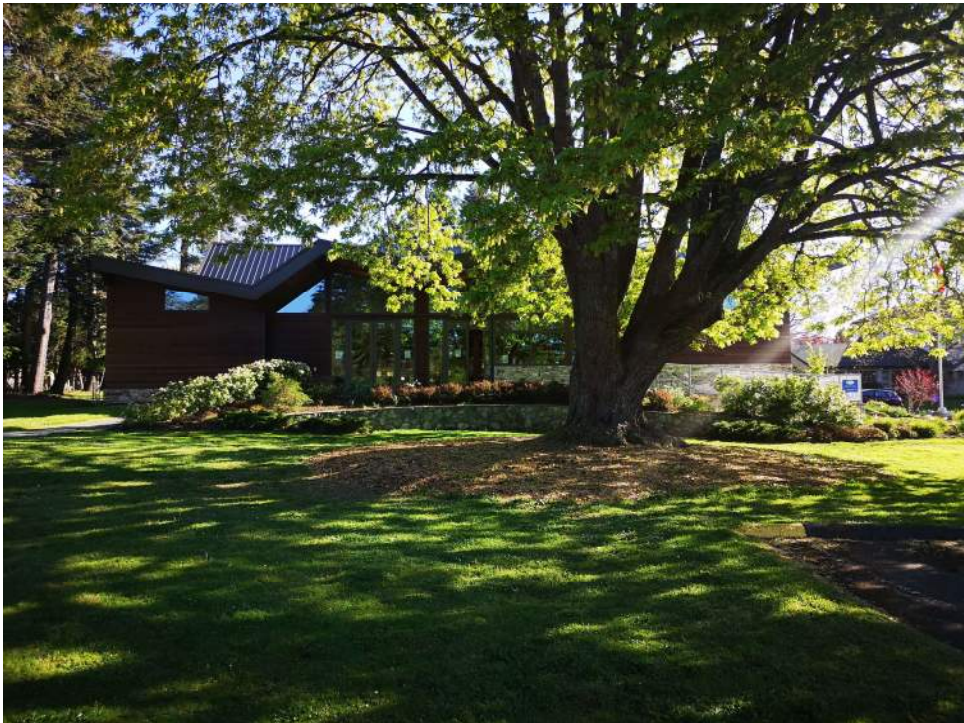
Photo - G20 50 00.00 - Soft Landscaping / Throughout Site
