Contingency Reserve Fund Study - Final

St. George the Martyr Church and Hall

Report No. 2302407.00
November 15, 2024

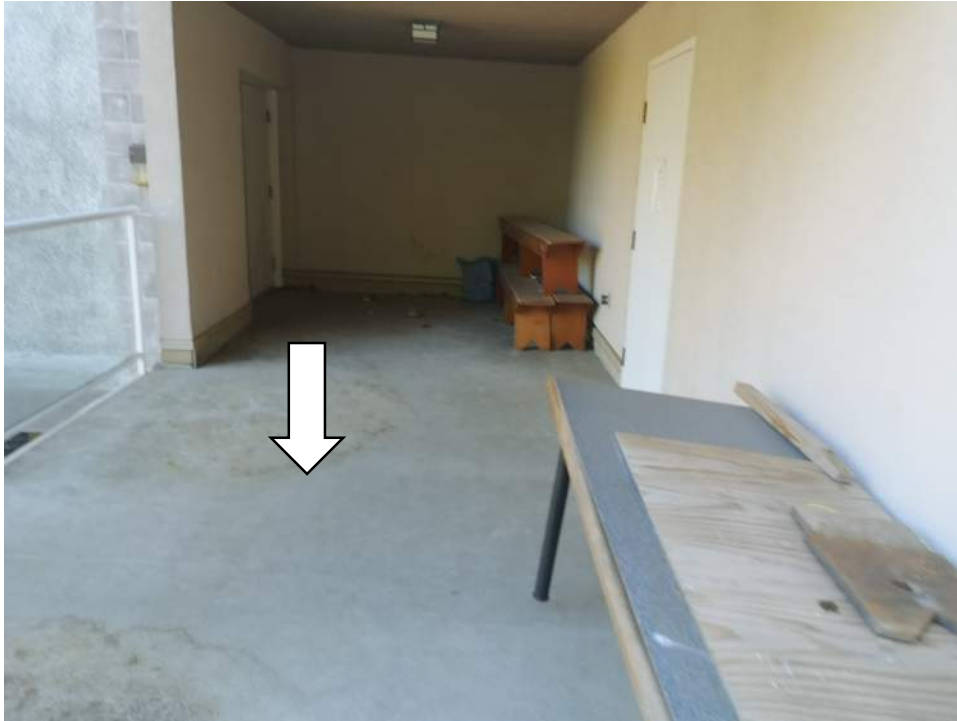
Photo - B10 10 04.01 - Balcony, Vinyl Waterproofing - Replacement / Southeast Corner of Building

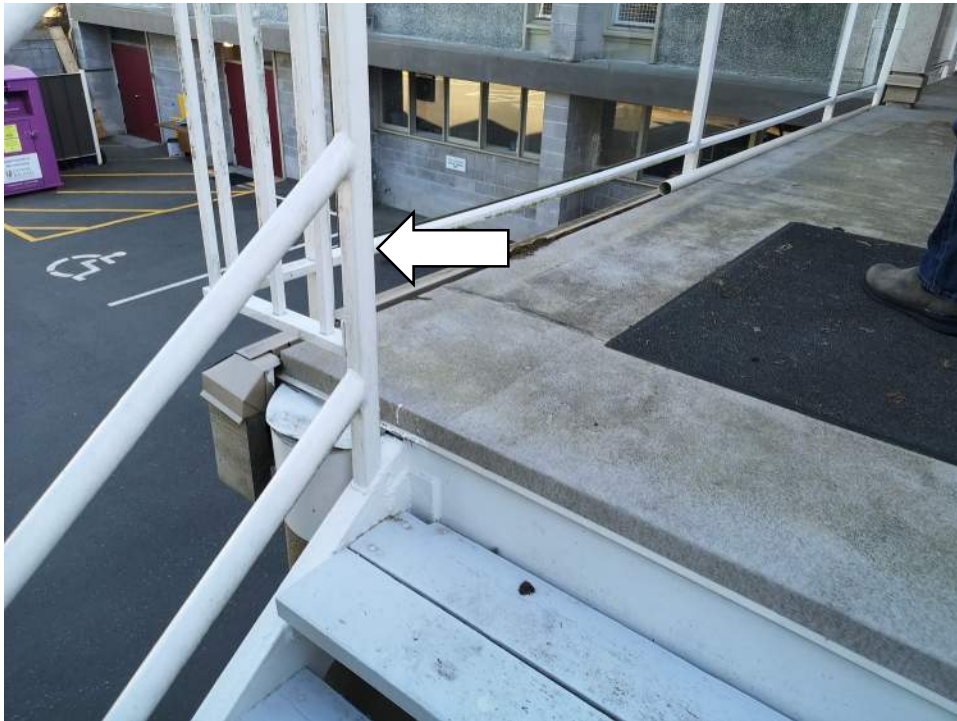
Photo - B10 10 04.02 - Balcony, Guardrails - Replacement/ Southeast Corner of Building

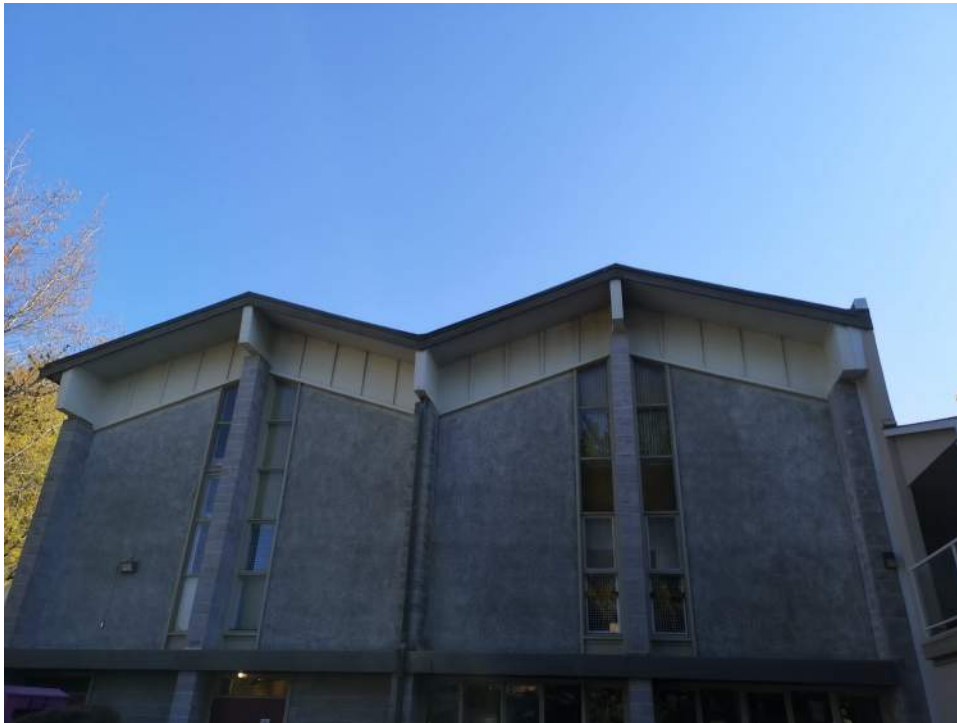
Photo - B20 10 01.01 - Stucco Cladding - Replacement / Exterior Walls

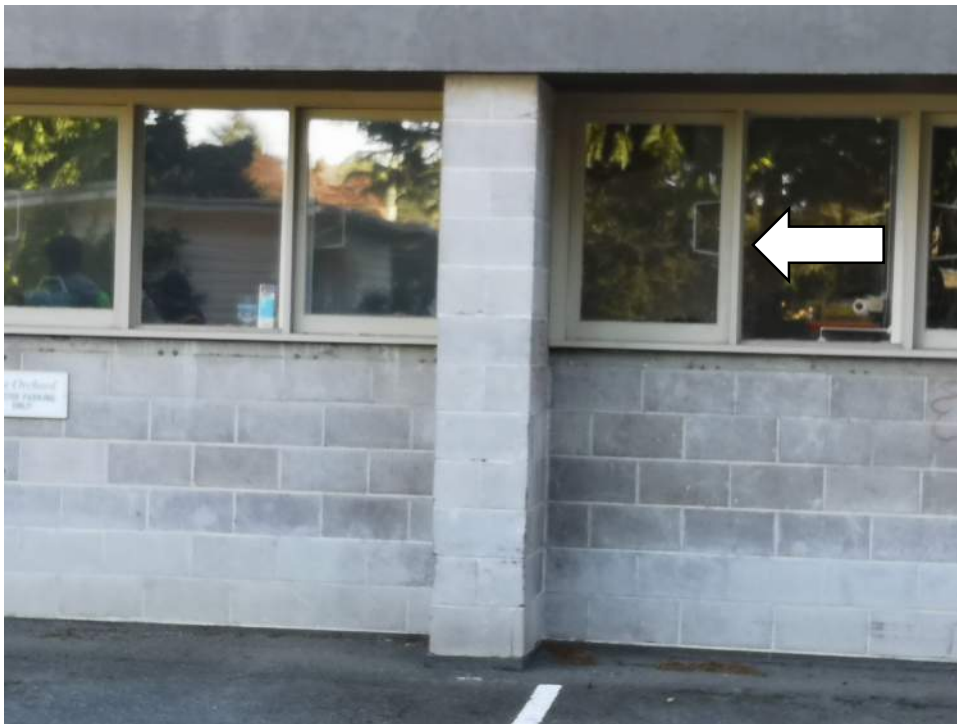
Photo - B20 20 01.01 - Exterior Windows, Wood-Framed - Replacement / Throughout Building Elevations

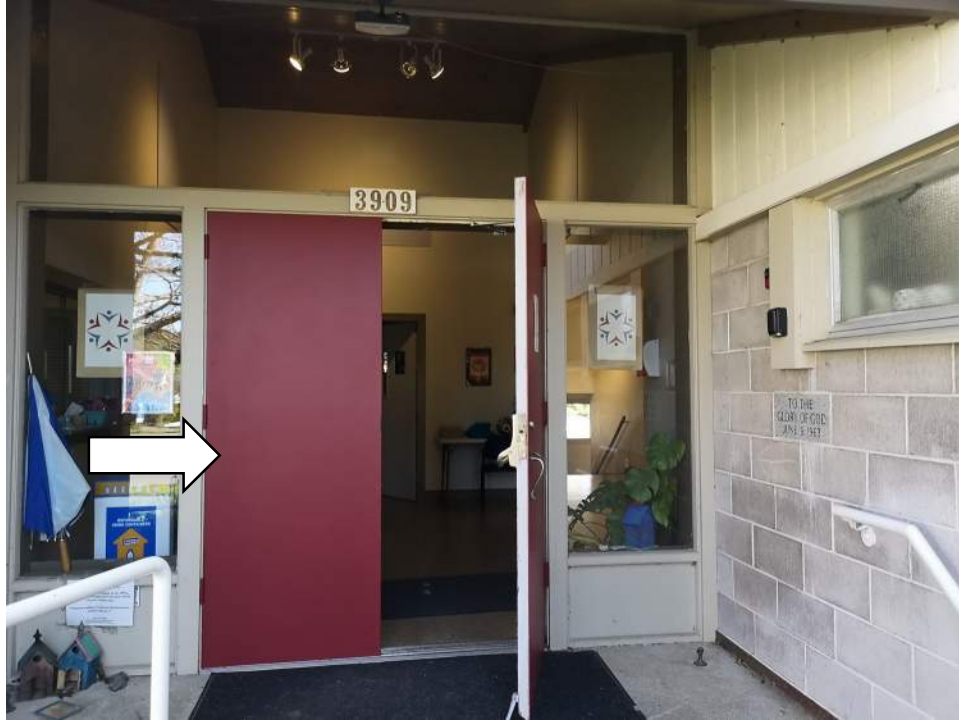
Photo - B20 30 02.00 - Metal Swing Doors - Entrances / Replacement

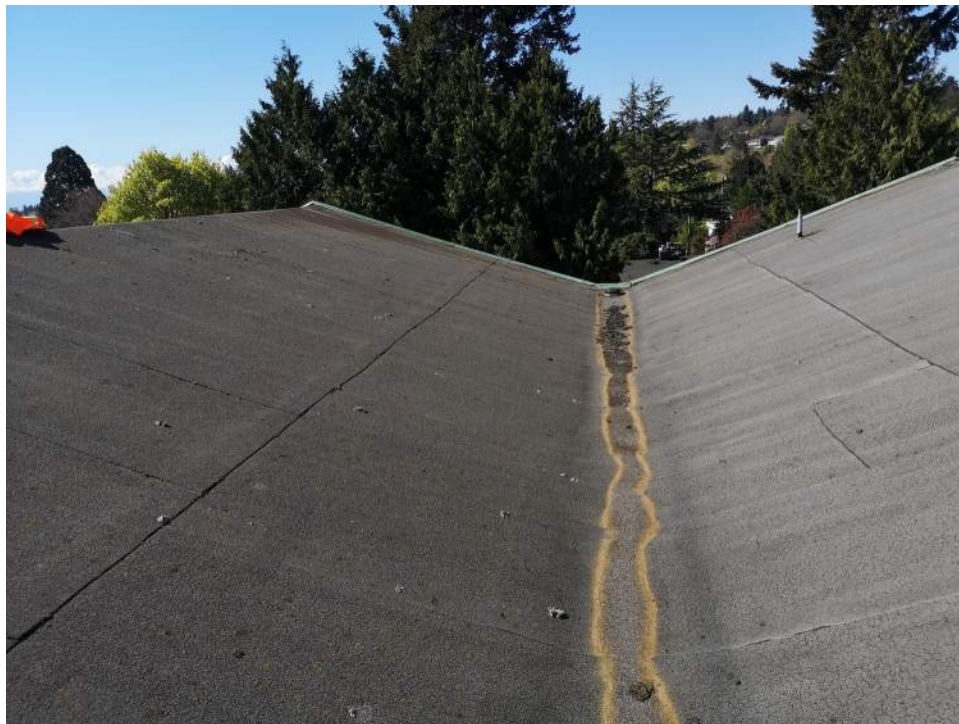
Photo - B30 10 02.01 - SBS Modified Bitumen Assembly - Replacement / Low-Sloped Main Roof Areas

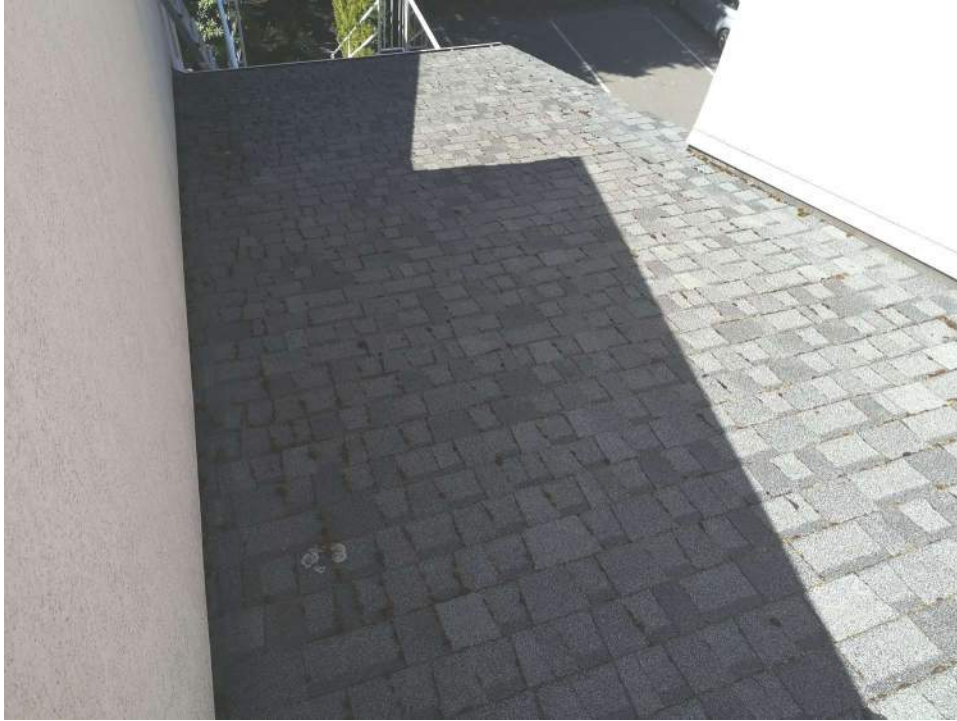
Photo - B30 10 02.02 - Asphalt Shingles - Replacement / Over Southeast Emergency Exit Deck

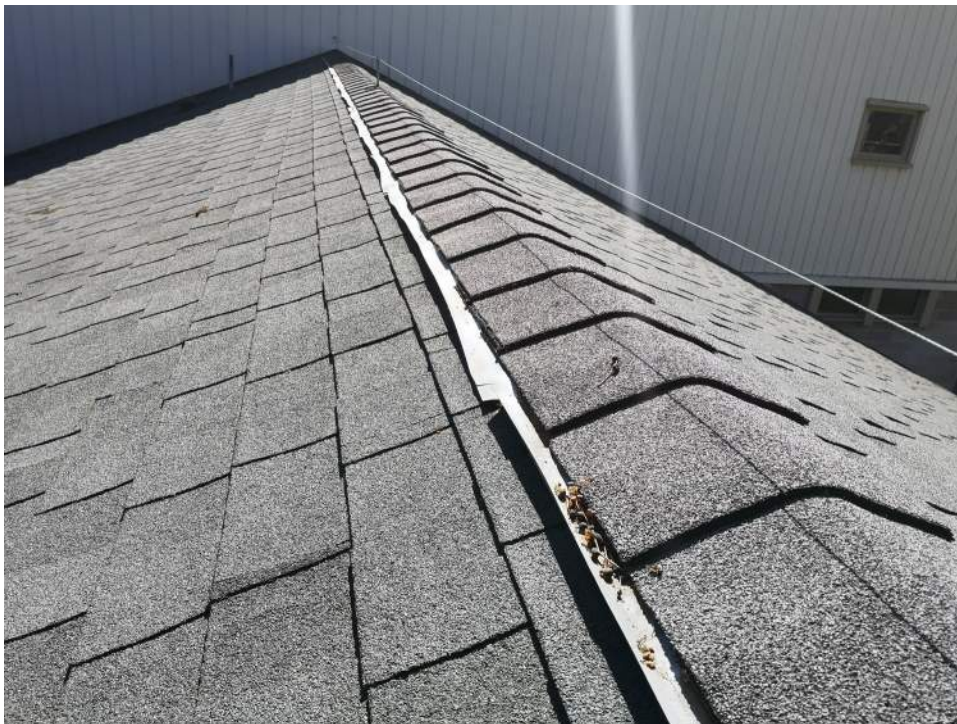
Photo - B30 10 02.03 - Asphalt Shingles - Replacement / One Story Office Section of the Building

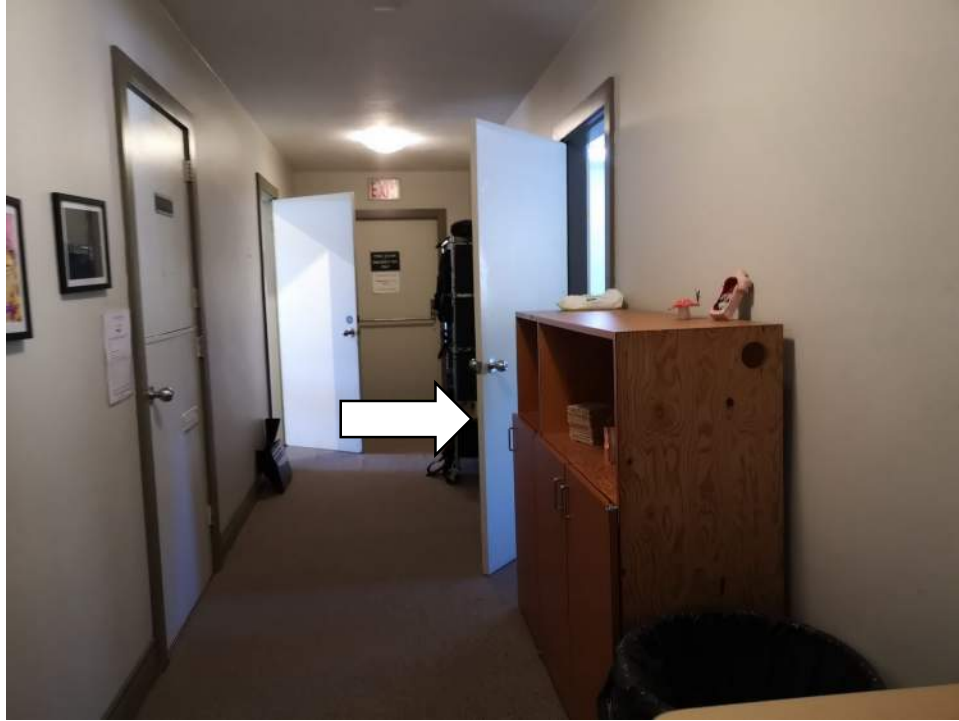
Photo - C10 20 03.00 - Interior Doors - Repairs / Office, Classroom, Utility Spaces and Common Areas

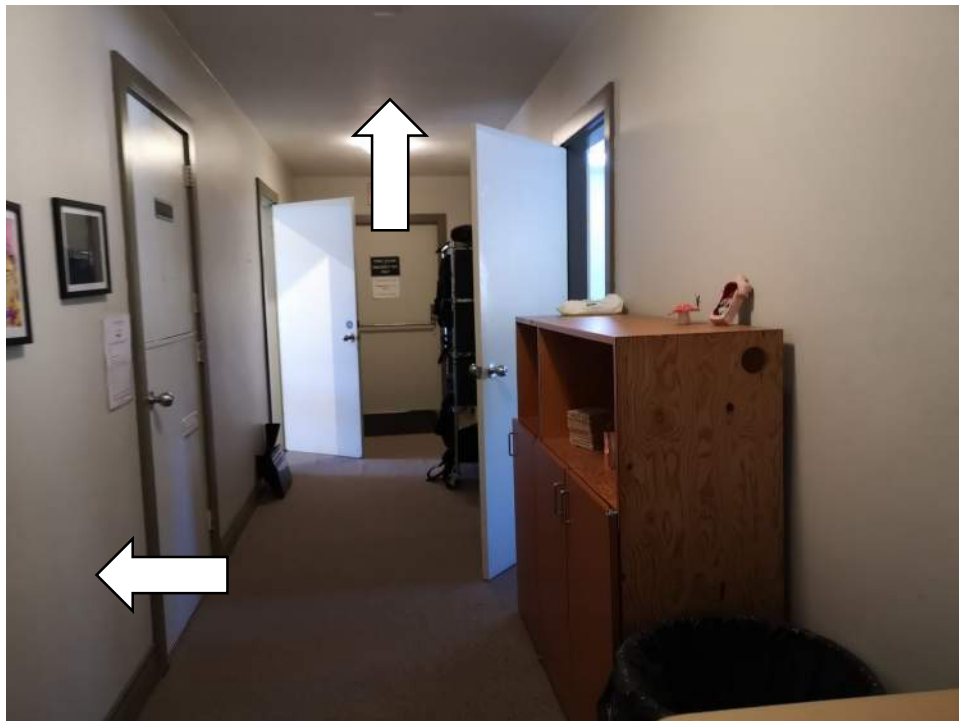
Photo - C30 00 00.01 - Interior Finishes - Wall and Ceiling Repainting / Hallways, Offices and Classrooms

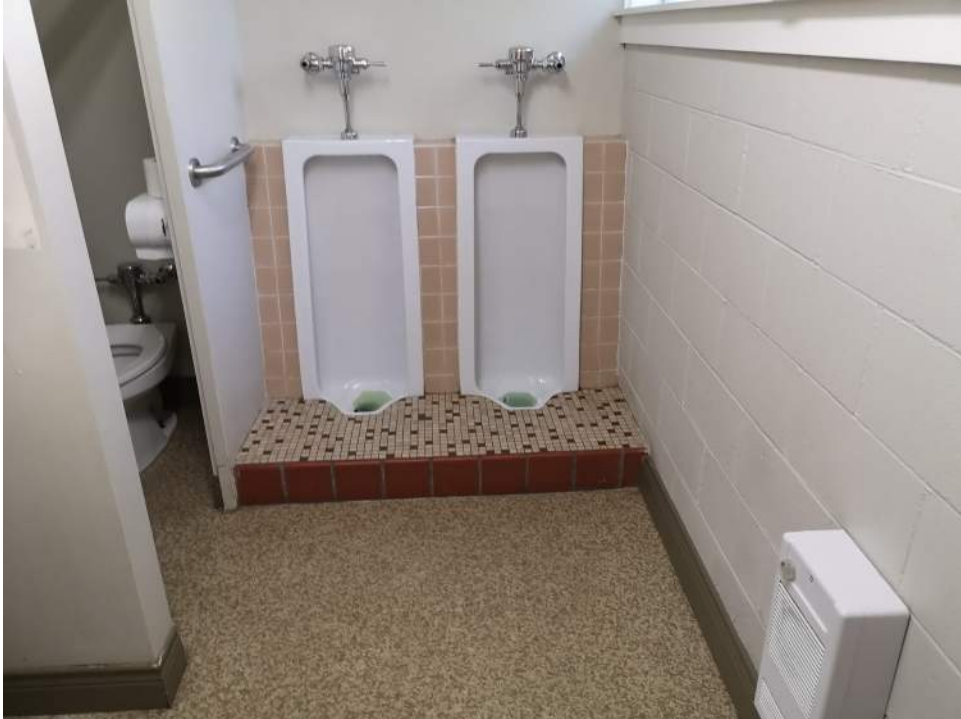
Photo - D20 10 02.01 - Plumbing Fixtures - Replacement / Washrooms

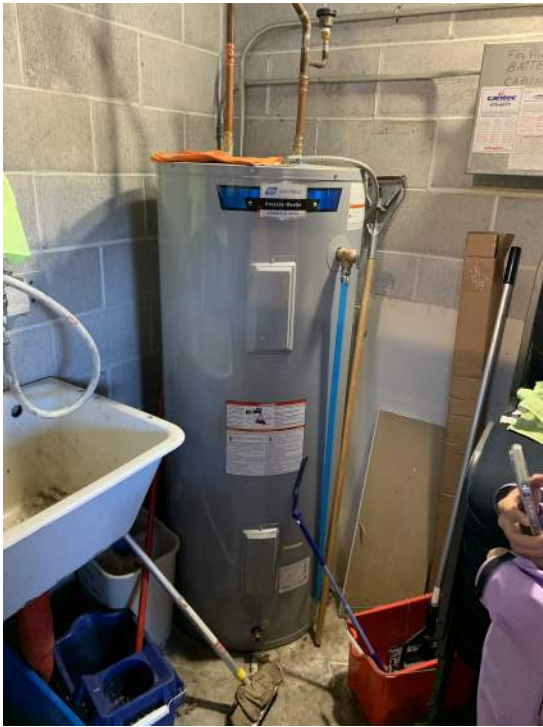
Photo - D20 20 31.00 - Water Heater Tank - Replacement / Hall Boiler Room

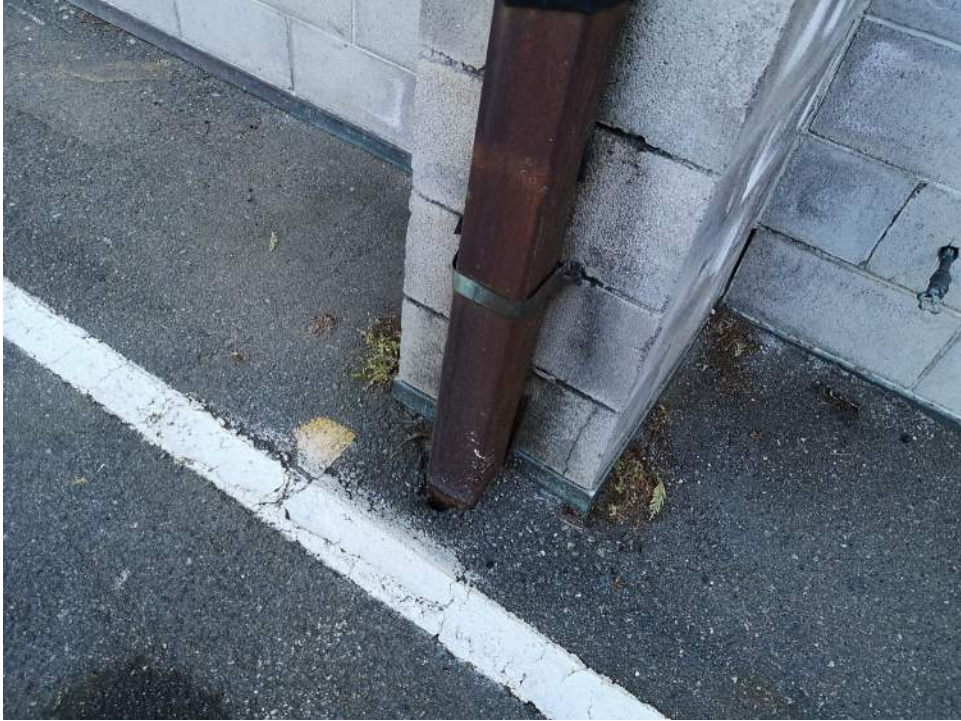
Photo - D20 30 00.03 - Storm Water - Eavestroughs and Downspouts / Around Building

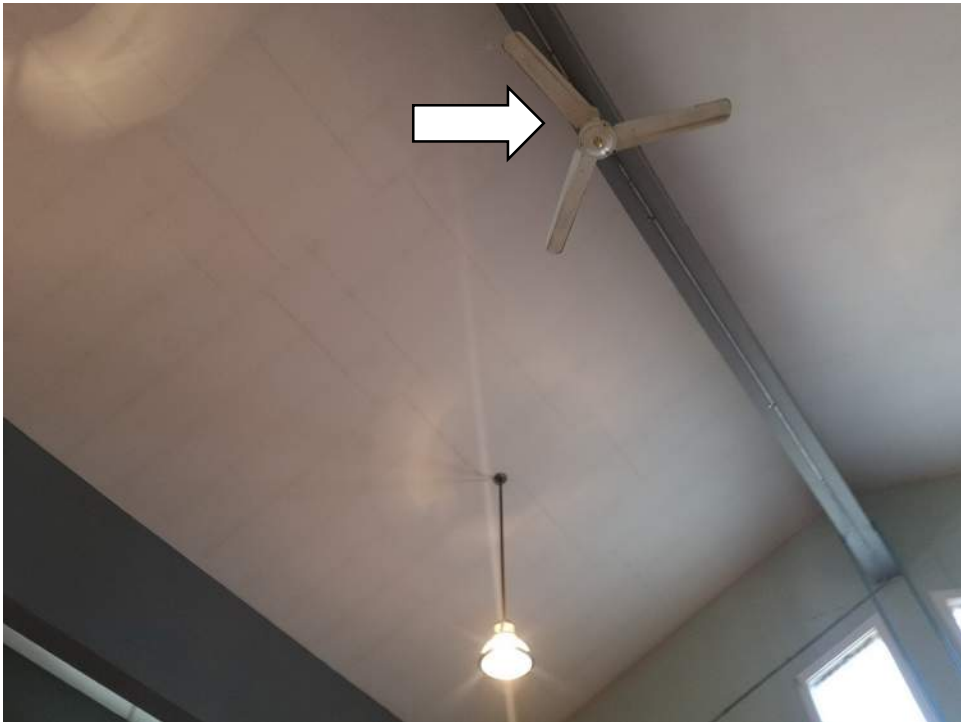
Photo - D30 30 02.00 - Ceiling Fans - Replacement / Gymnasium

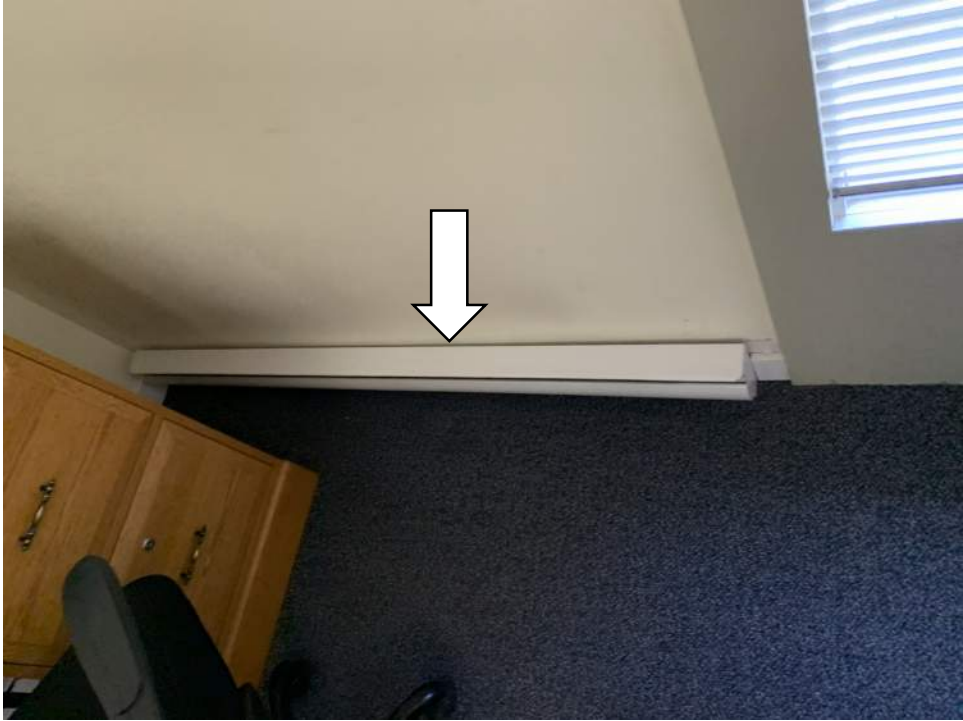
Photo - D30 50 06.01 - Electric Baseboard Heaters - Replacement / Office, Classrooms, and Lower Hall Area

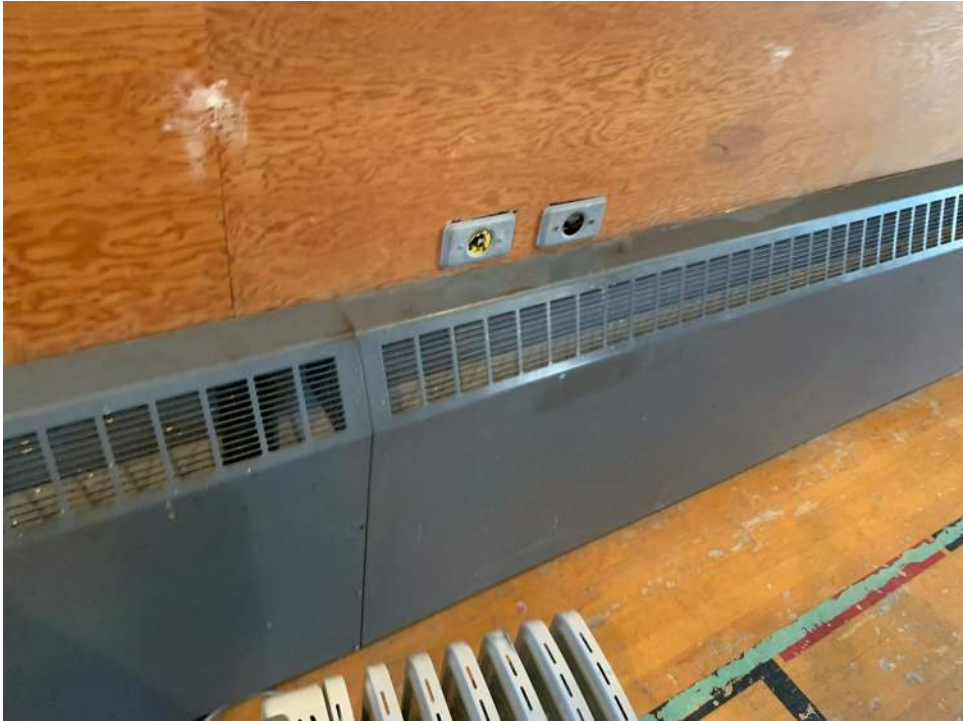
Photo - D30 50 06.02 - Hydronic Baseboard Heaters - Replacement / Throughout

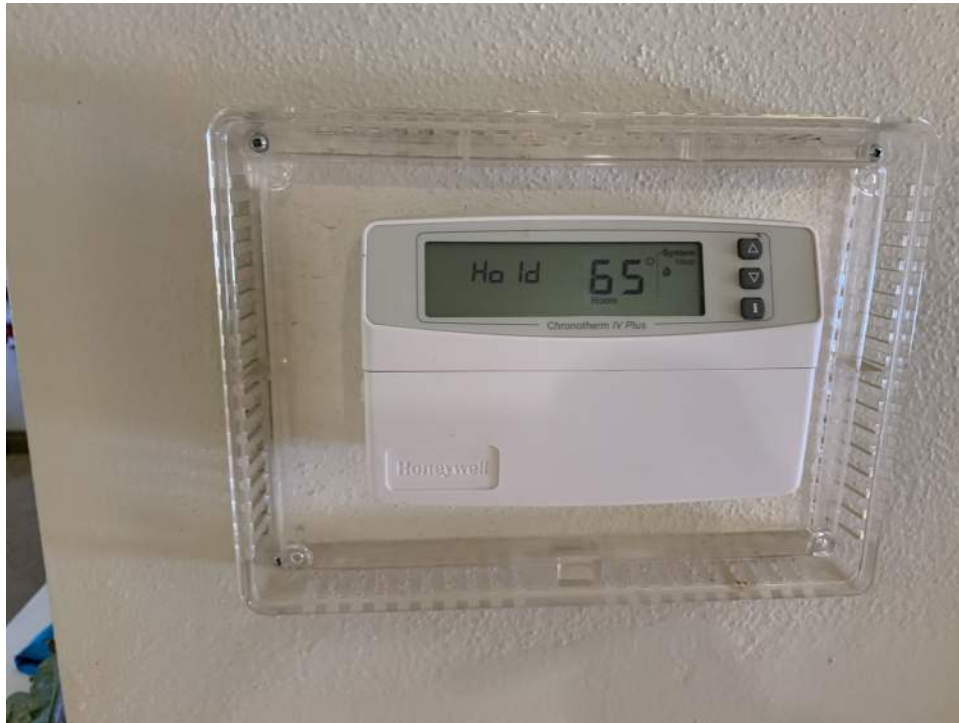
Photo - D30 60 02.00 - HVAC Controls - Replacement / Throughout

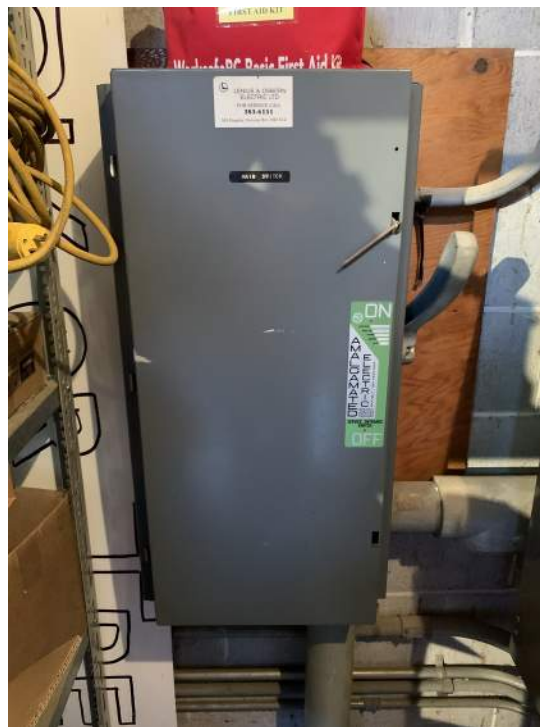
Photo - D50 10 03.01 - Main Distribution Equipment - Replacement / Hall Boiler Room - Kitchen

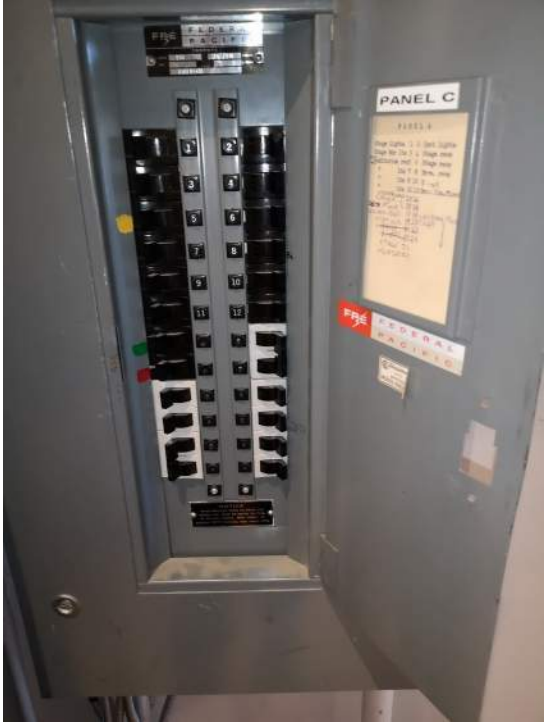
Photo - D50 10 05.00 - Branch Circuit Panels - Replacement / Various Locations

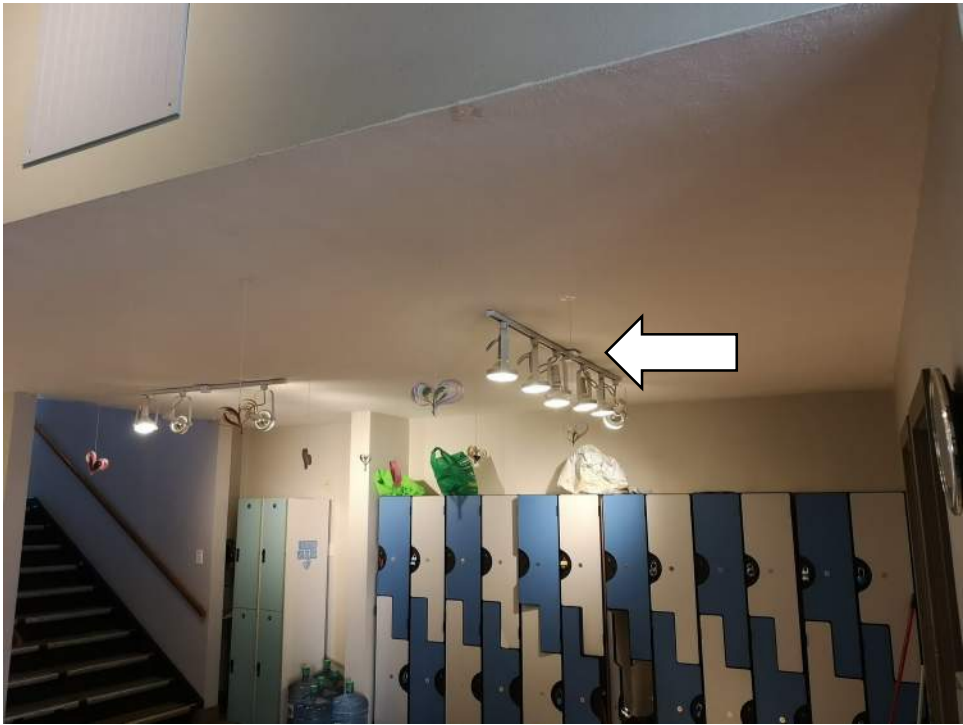
Photo - D50 20 02.01 - Interior Lighting - Replacement / Hallways, Stairwells, Offices, Classrooms, and Gymnasium

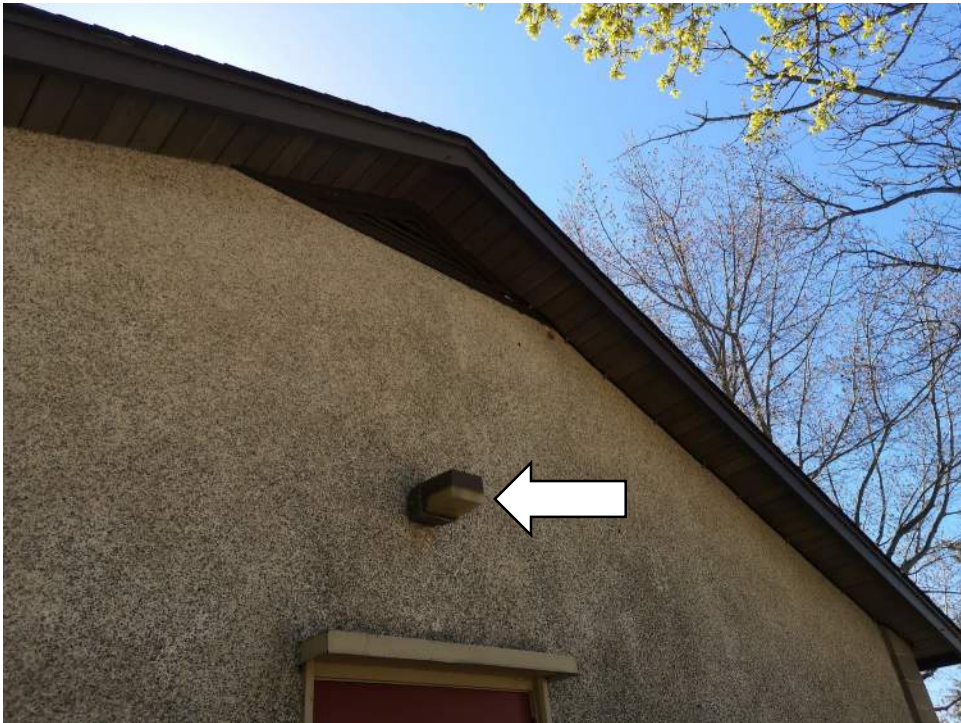
Photo - D50 20 02.02 - Exterior Lighting – Replacement

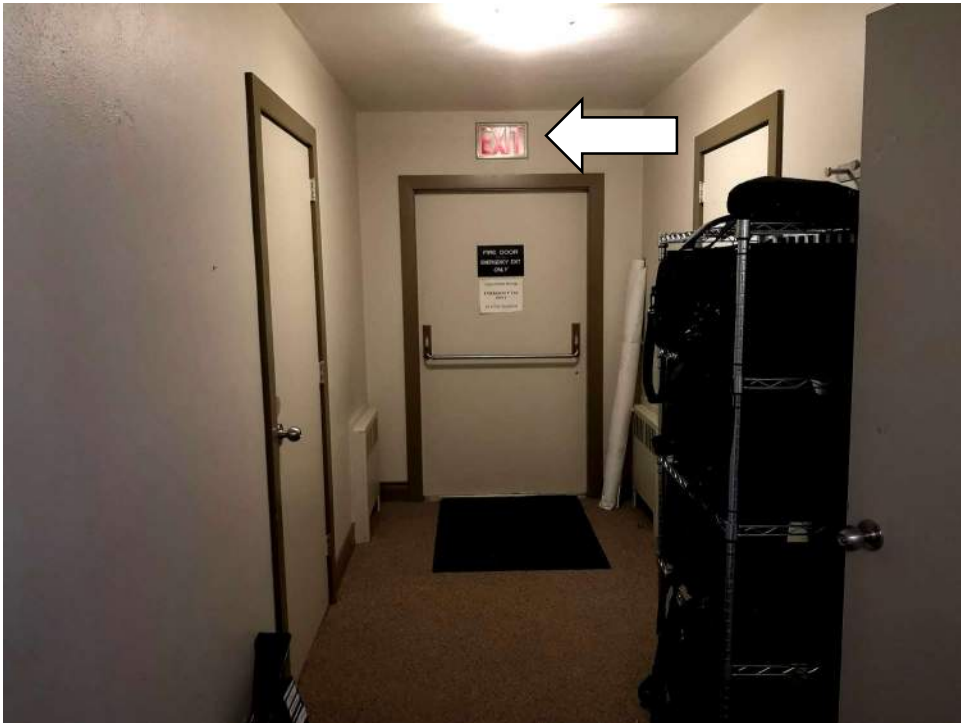
Photo - D50 20 99.00 - Emergency Lighting - Replacement

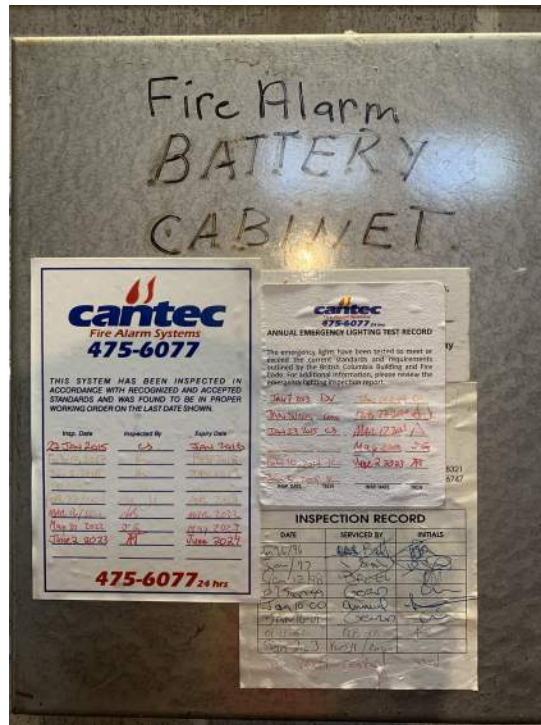
Photo - D50 30 01.00 - Fire Alarm System - Replacement / Throughout

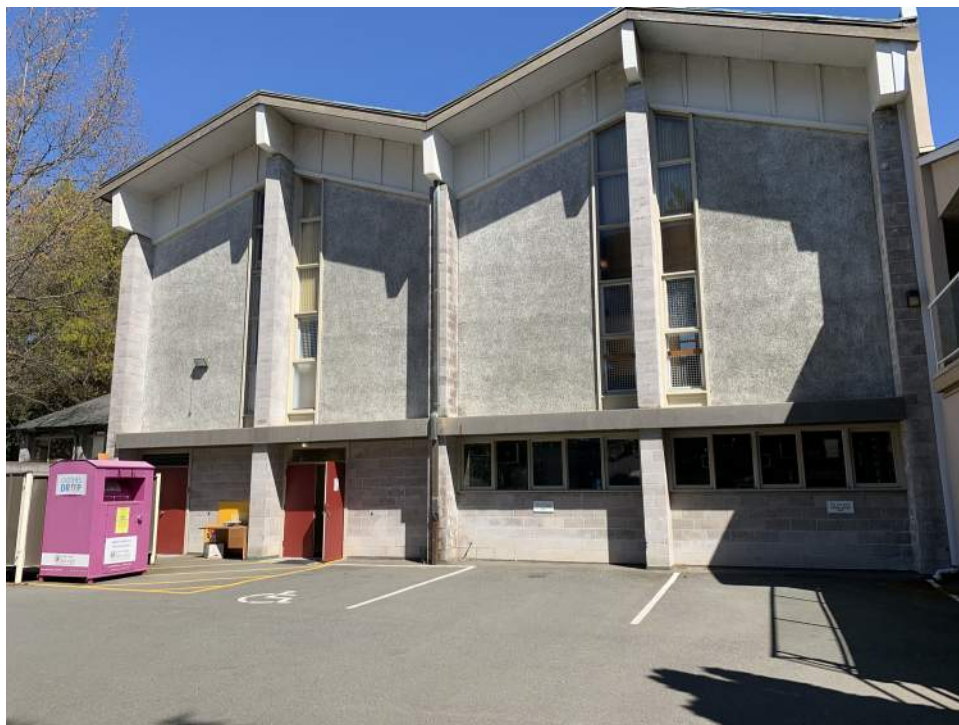
Photo - G20 10 00.01 - Asphalt Pavement - Resurfacing / Parking Areas
